CULTURAL LANDSCAPE REPORT

FINAL - APRIL 2014

GUNFLINT TRAIL
HISTORICAL SOCIETY

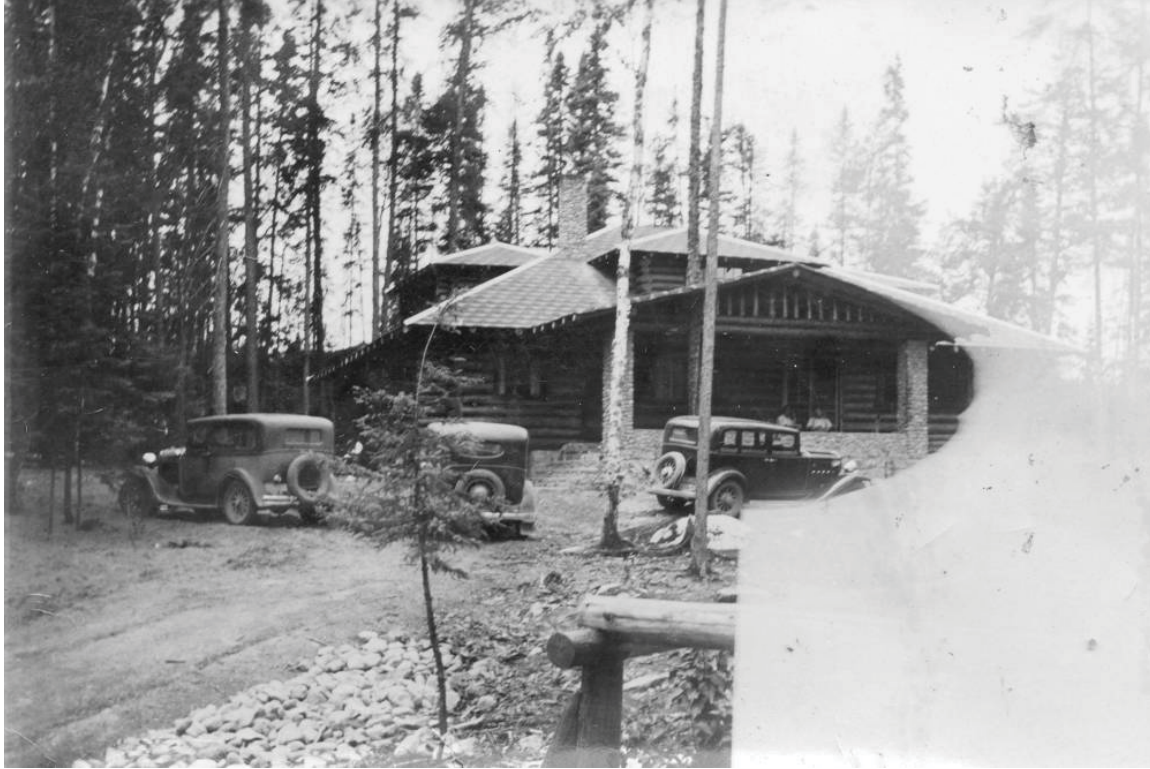
Figure 2- 2: Second Chik-Wauk Lodge (first building in this location), constructed of logs with stone porch, ca. 1932 or 1933. (source: C-W 198)

- 1931-32 Edwin Nunstedt and his son, Art, constructed a log lodge (“Old Lodge”) near the road and five small cabins on the property.³⁴
- 1933-34 Summer – the log lodge at the current museum location accidentally burned. The entire structure, excepting the stone porch, was lost. In the fall of the same year construction of a new stone lodge began.³⁵

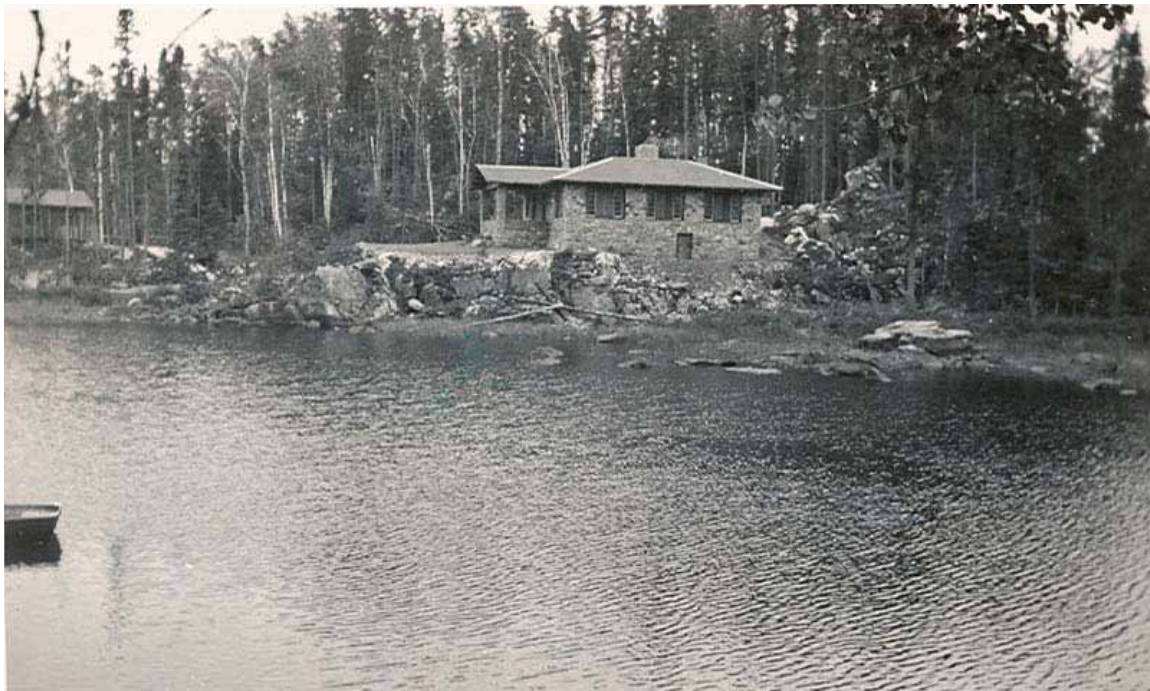
Figure 2- 3: Third Chik-Wauk Lodge/Main Lodge (second at this location), constructed of stone on site of original lodge, October 1934. (source: C-W 2)

The first lodge at the current museum site was of log construction and it burned soon after its completion. It was replaced by a stone building – the extant museum, referred to herein as the lodge, the main lodge, and Chik-Wauk lodge. Additional guest cabins, docks, sheds, a boathouse, quarters for the owners and workers, and other necessary structures were built during the ensuing years. Eventually they had six “American Plan” cabins—including meals served at the Lodge; four “housekeeping” cabins—with kitchen facilities so guests could prepare their own meals; and one remote cabin in Canada on Northern Light Lake (outside the project area).

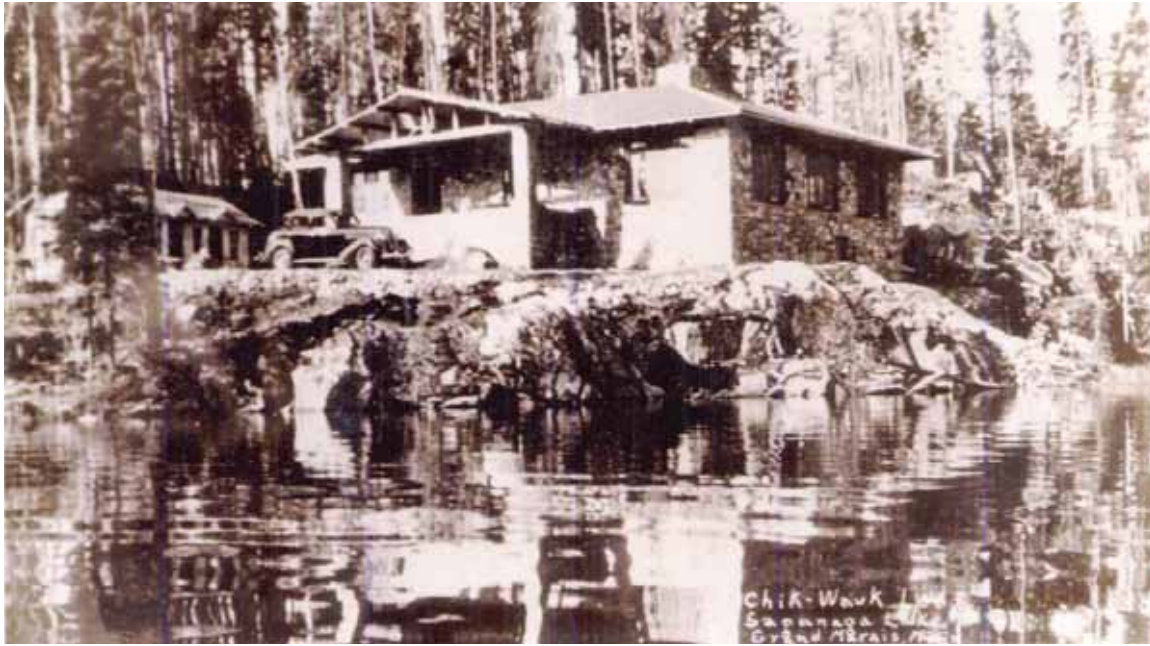
Figure 2- 10: Chik-Wauk Lodge, the Laundry/Pantry/Dry Good Storage building is in the background on the left. (source: C-W 70)

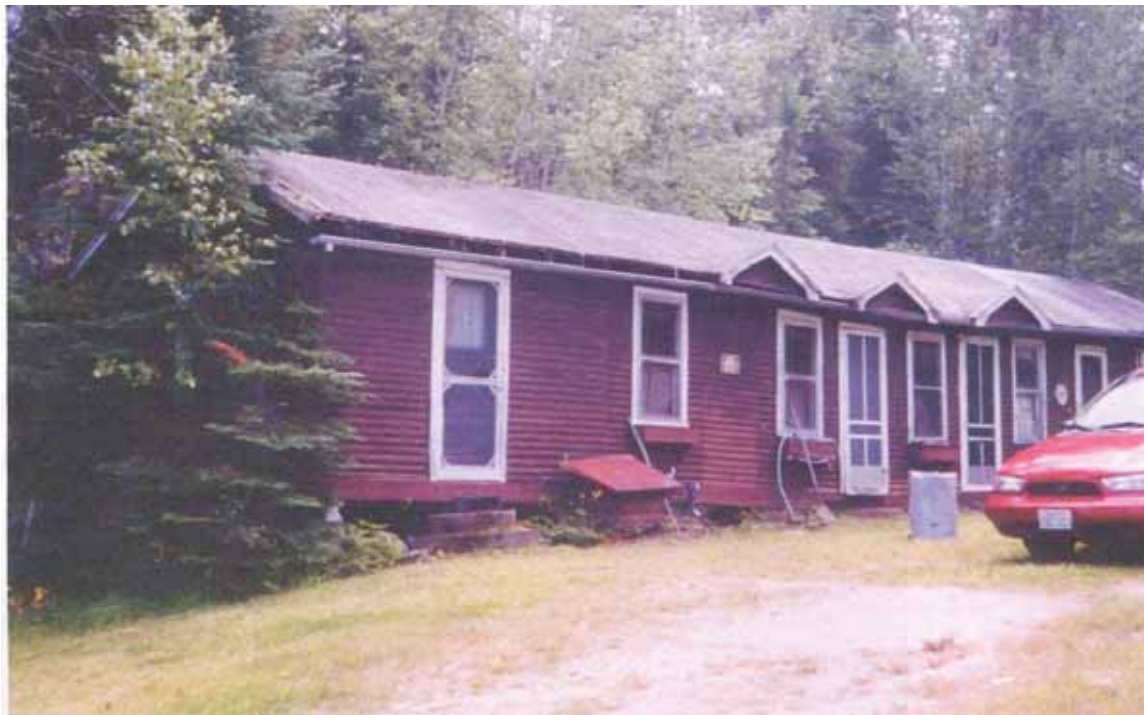
Figure 2- 11: Laundry/Pantry/Dry Good Storage building. (source: C-W 162)

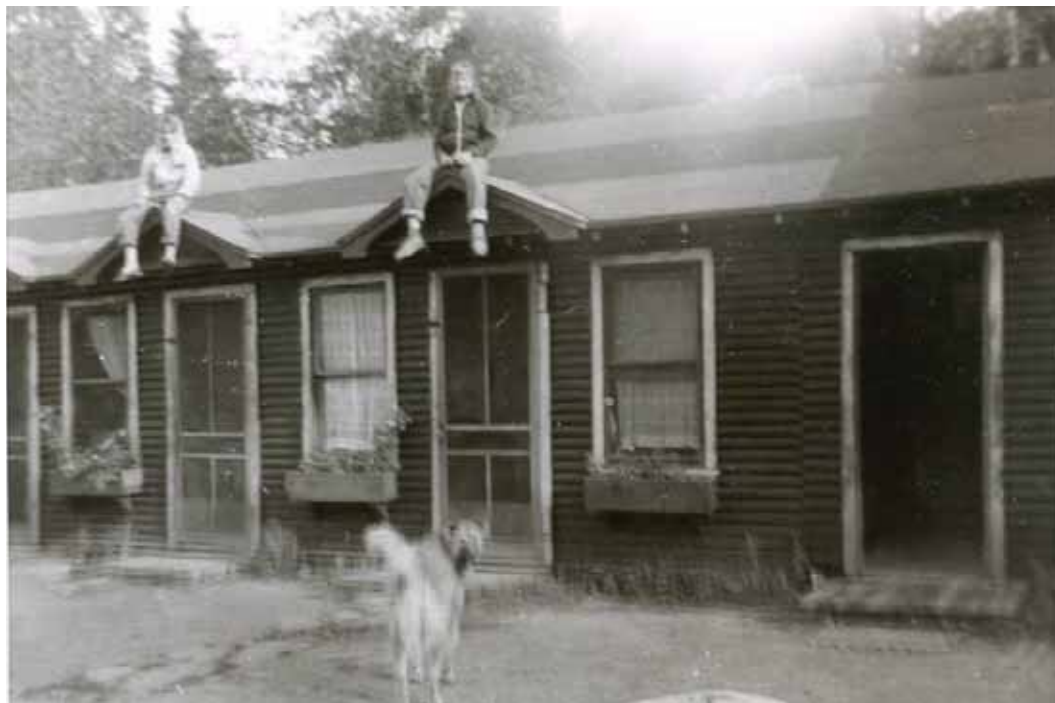
Figure 2- 14: Multipurpose / laundry building. (source: C-W251, from Phyllis Noyes) Note the stone path to the door, the flower boxes, and the bare earth.

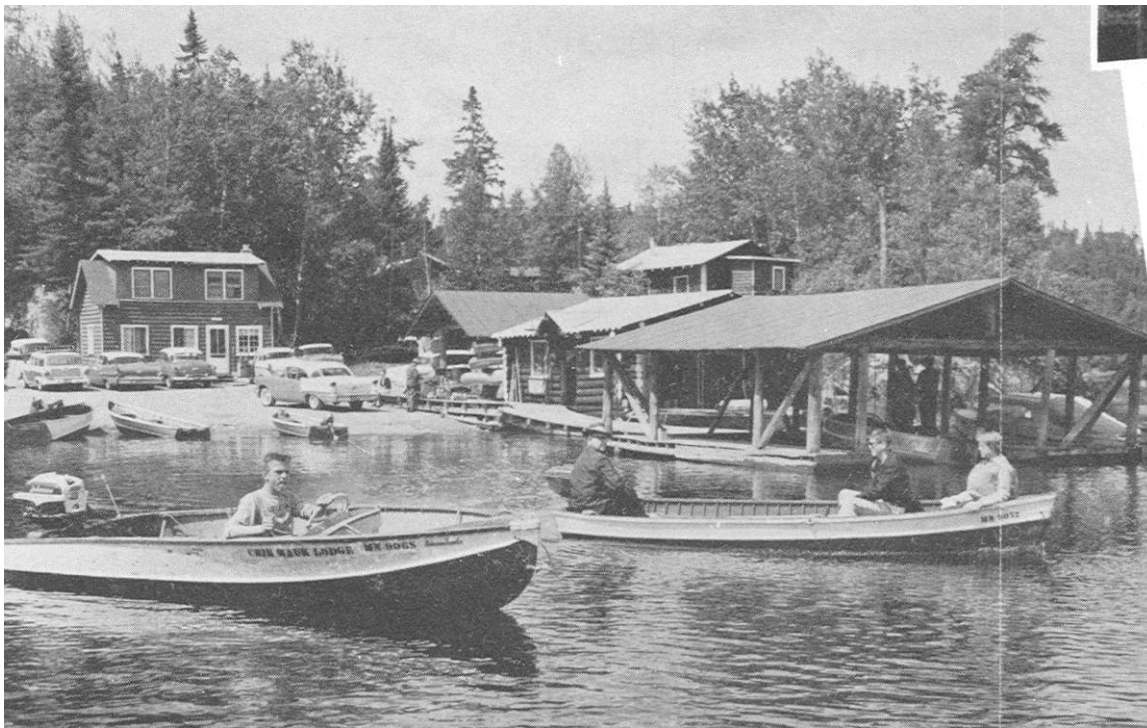
Figure 2- 20: Office, boathouse and area around docks, ca.1960. (source: C-W 240a, excerpt from Chik-Wauk brochure, page 2)

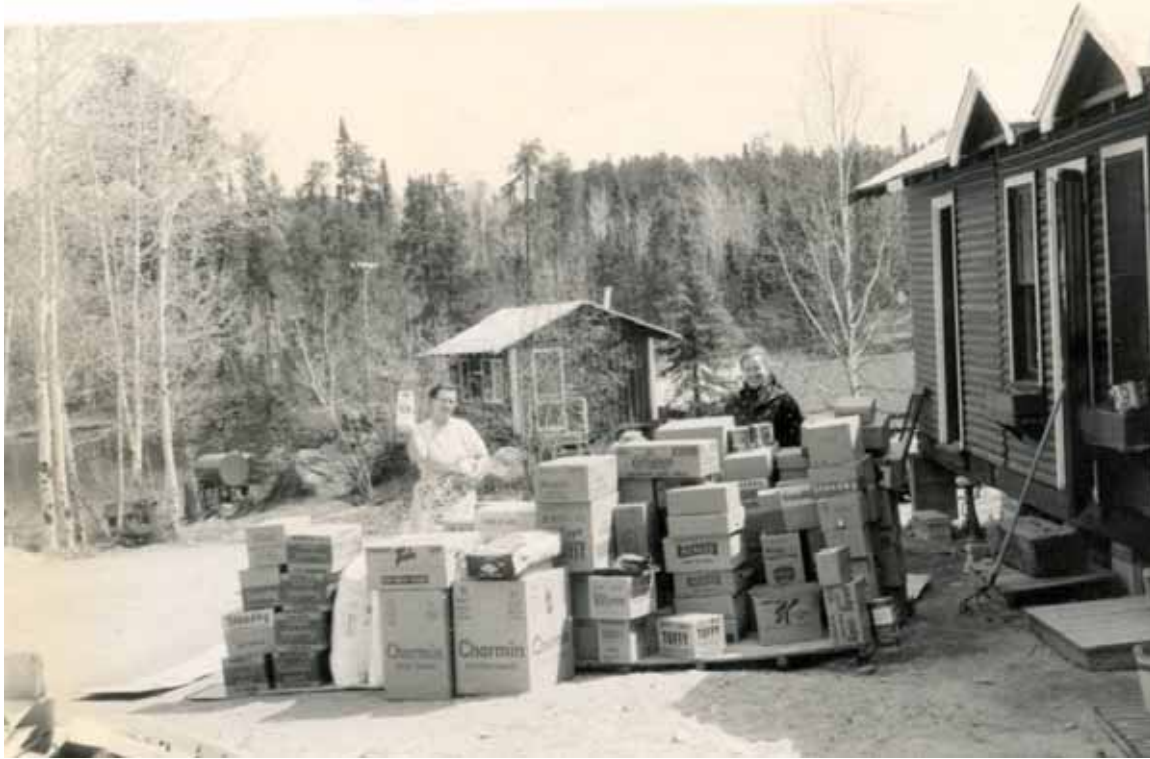
Figure 2- 25: Guest Cabin #1 (#4 Cabin), left and Laundry/Pantry/Dry Good Storage building, right, with spring supplies. (source: C-W 203)

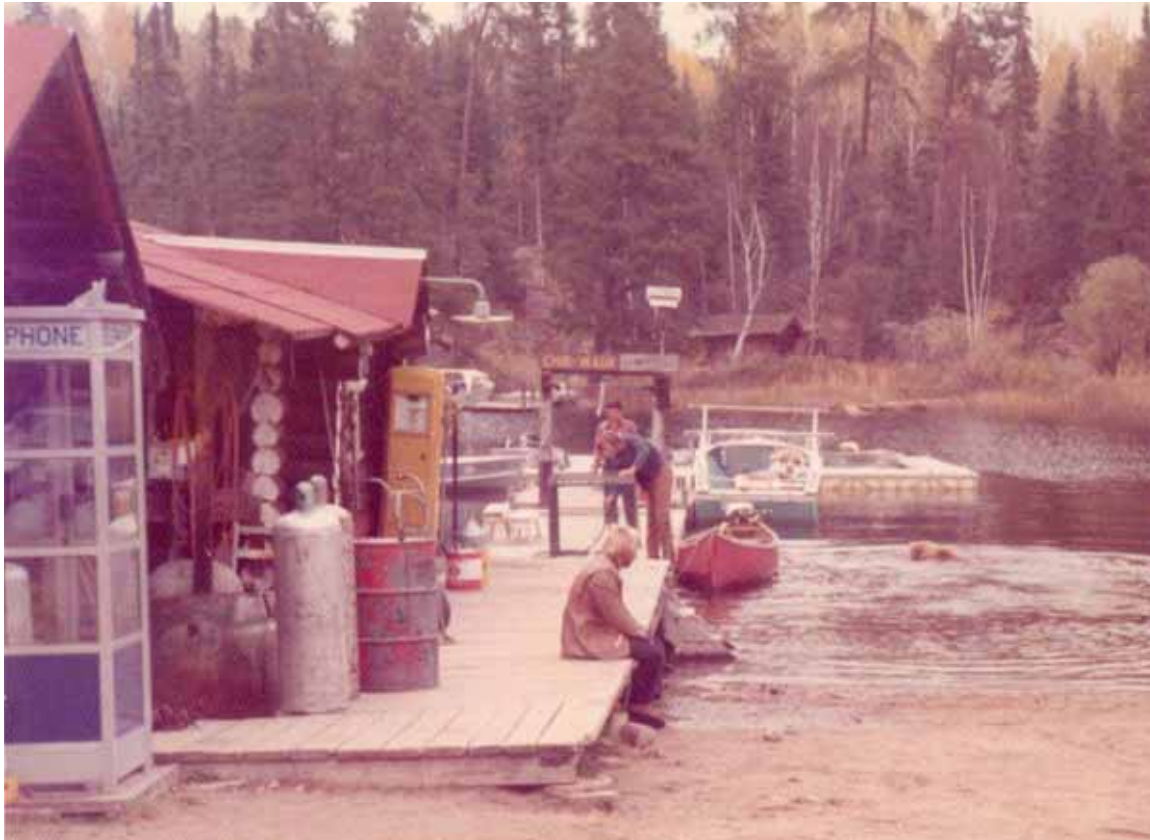
Figure 2- 31: Dock and adjacent buildings. Note building (#24) across the bay, 1973 (source: C-W 168)

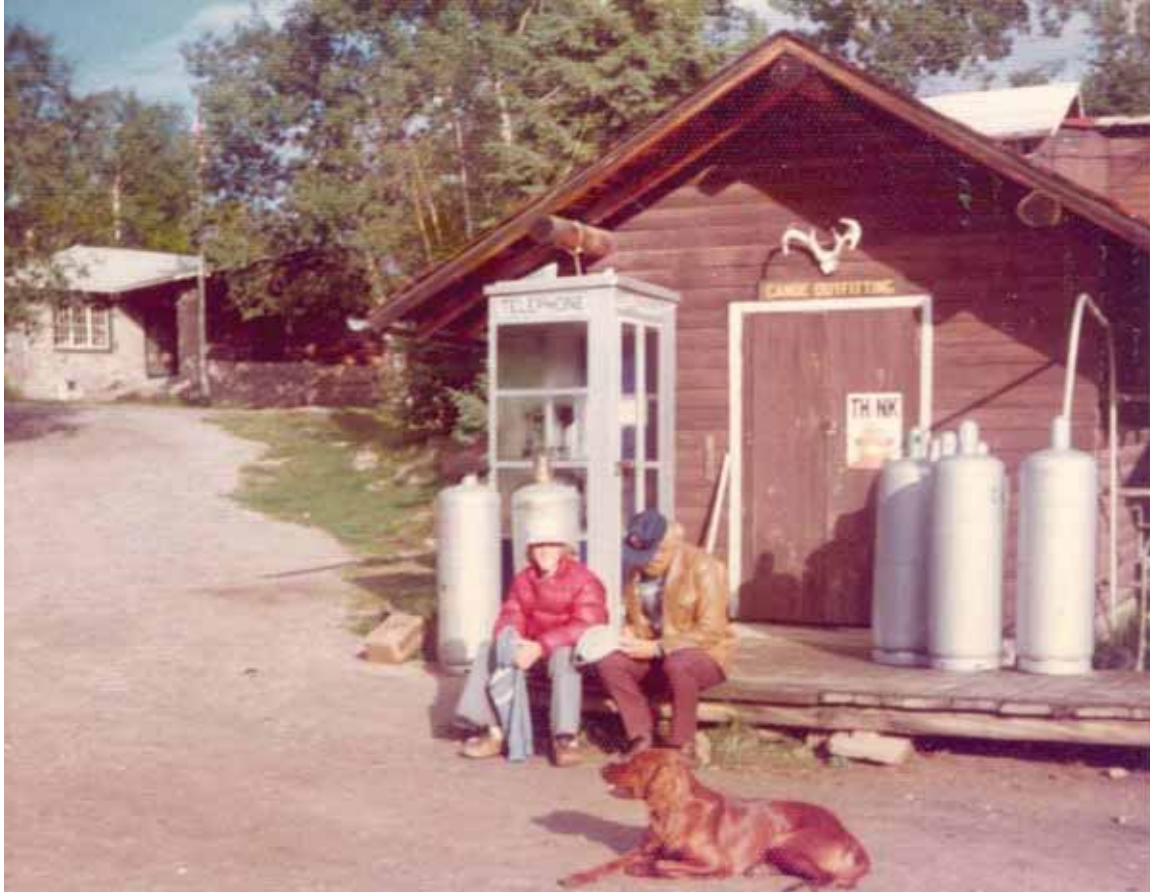
Figure 2- 40: Garage/ Ice House/ Fish Cleaning building, 1973. The sign was added for the Hamm's beer commercial. (source: C-W 181)

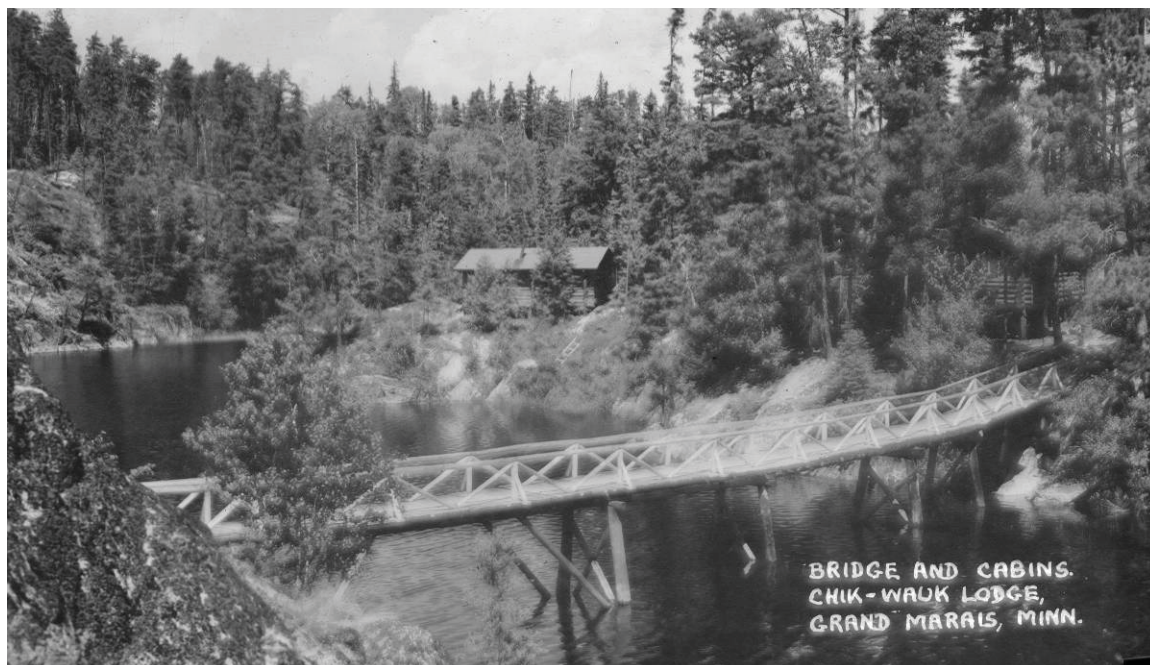
Figure 2- 58: Footbridge at Chik-Wauk with Judge's Cabin (#2 Cabin) on left.
(source: left C-W 21, right C-W 45 & same as C-W 54)

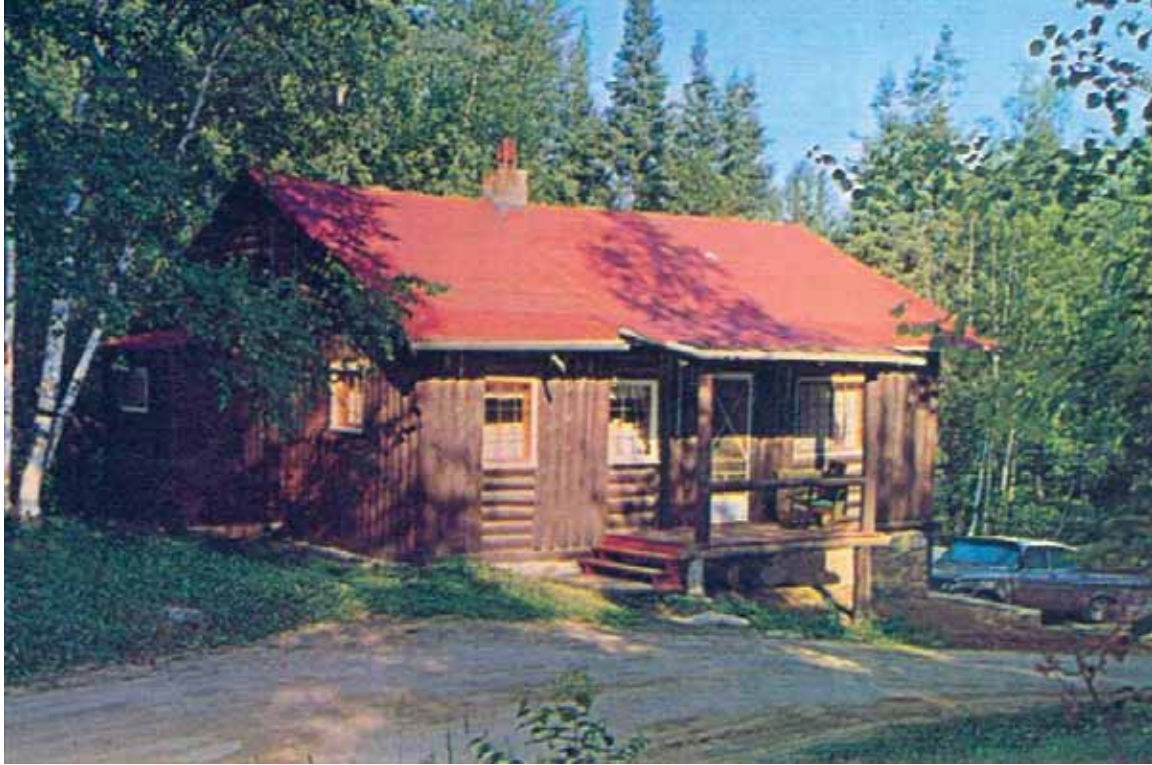
Figure 2- 67: Porch at the Old Lodge, (#12 Cabin), 1935 (source: C-W 50)

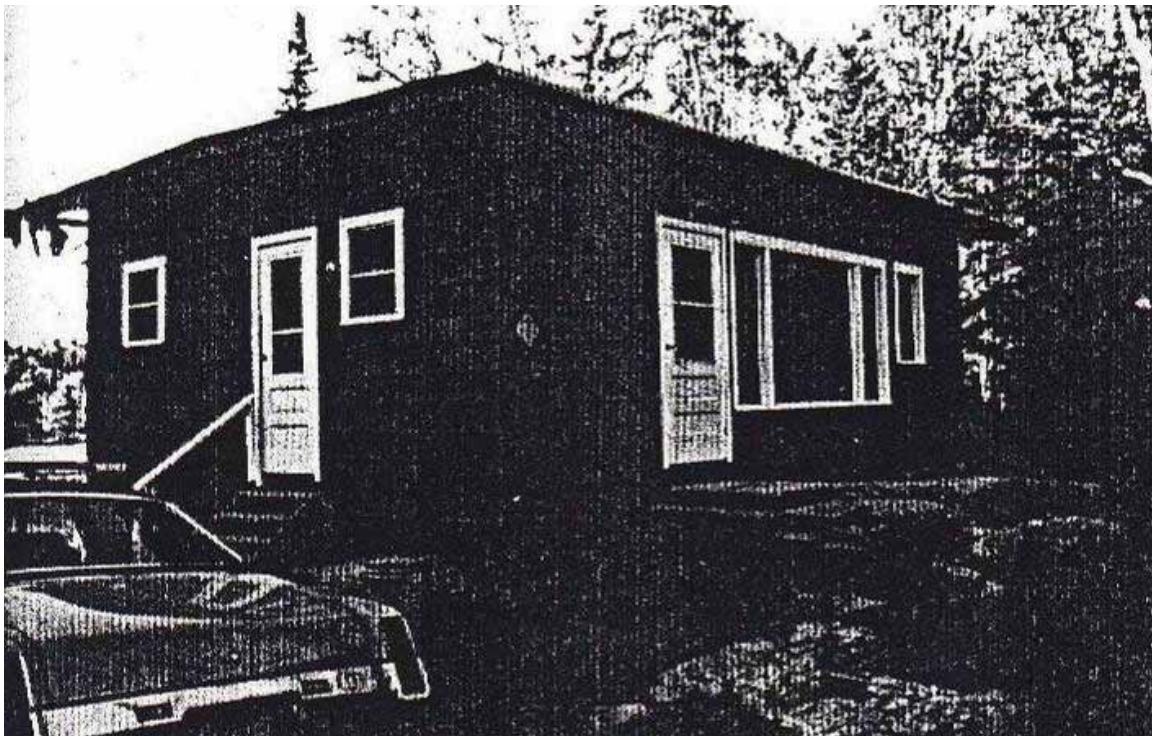
Figure 2- 68: Old Lodge (#12 Cabin), later view with stone foundation. (source: C-W 46, picture is from Sharon Eliassen)

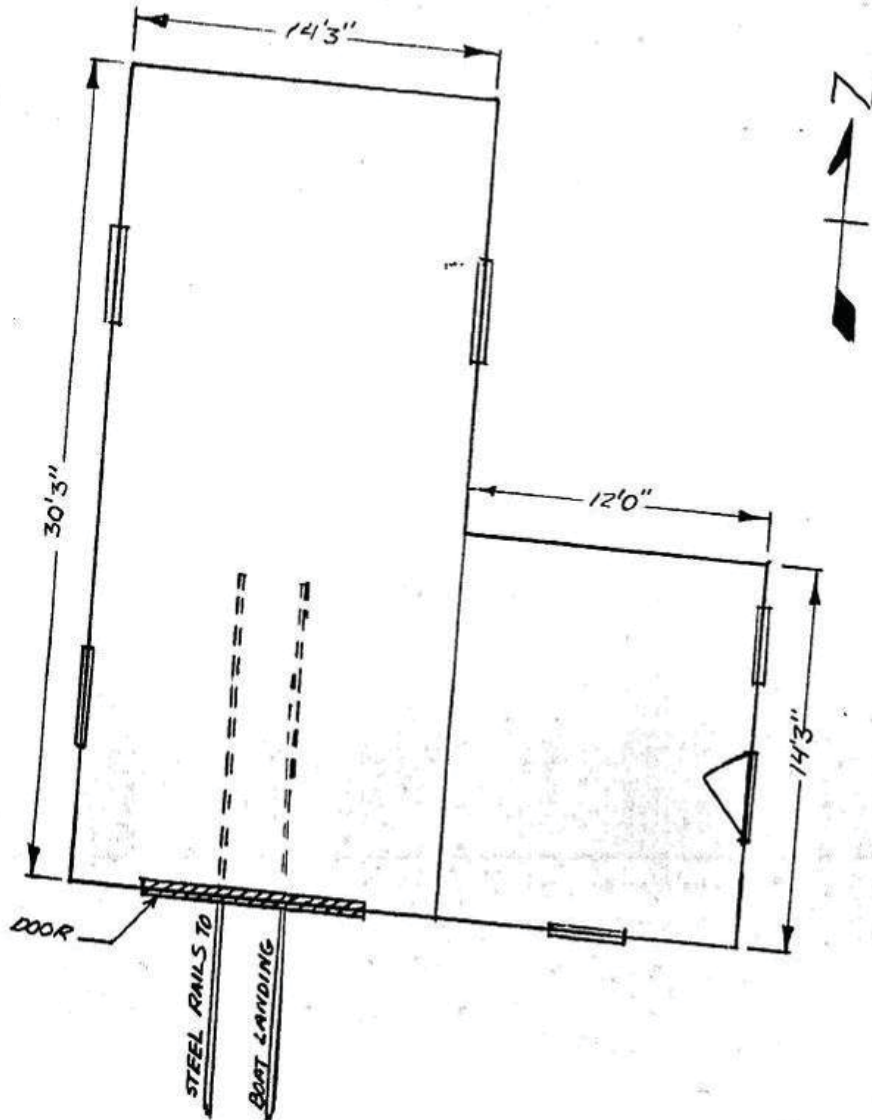
- 1932 Boathouse at Chik-Wauk constructed in 1932 on land across the bay by USFS. One story frame building with two rooms with a gross floor area of 588 square feet. The building was set on a foundation of log sills, with lap siding, 2x4 framing and rafters, roll roof (by 1963), and a stove pipe chimney.³³

Figure 2- 74: Floor plan of USFS Boathouse at Chik-Wauk (source: USFS)

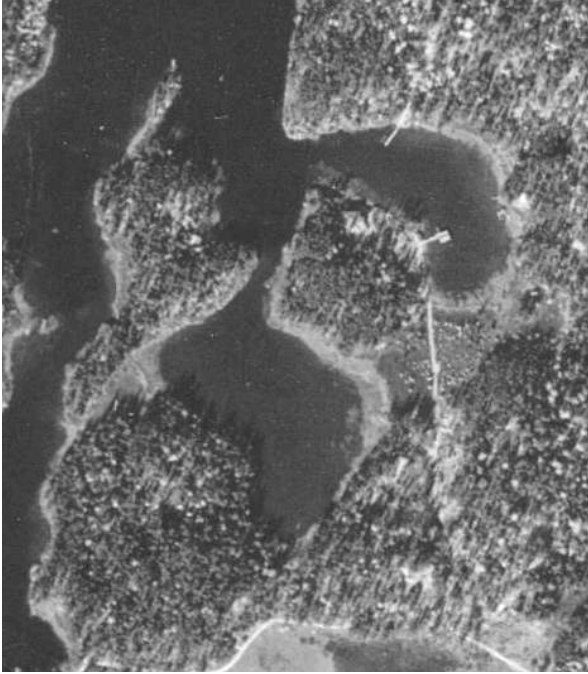
Figure 4- 1: Aerial photograph of Chik-Wauk property, 1937 (source: USFS, Superior National Forest)

Comparison of the historic conditions to existing spatial organization reveals that the bays and shores associated with the resort have remained consistent since the establishment of the resort (see Figures 4-1 through 4-6). The northern development area, including the lodge, parking area, and former sites of several cabins and outbuildings, is still legible as a resort landscape, despite the loss of the majority of the buildings. The extant lodge and strong association between it and views of the surrounding landscape are of primary importance to this area. The road and arrival area on the southwest side of north bay are also key aspects of this area. The southern development is harder to recognize, as the former building sites are not as apparent.

Figures A through C	Spatial Organization	Contributing	Comparison of the historic conditions to existing spatial organization reveals that the bays and shores associated with the resort have remained consistent since the establishment of the resort (see Figures 4-1 through 4-6). The northern development area, including the lodge, parking area, and former sites of several cabins and outbuildings, is still legible as a resort landscape, despite the loss of the majority of the buildings. The extant lodge and strong association between it and views of the surrounding landscape are of primary importance to this area. The road and arrival area on the southwest side of north bay are also key aspects of this area. The southern development is harder to recognize, as the former building sites are not as apparent.

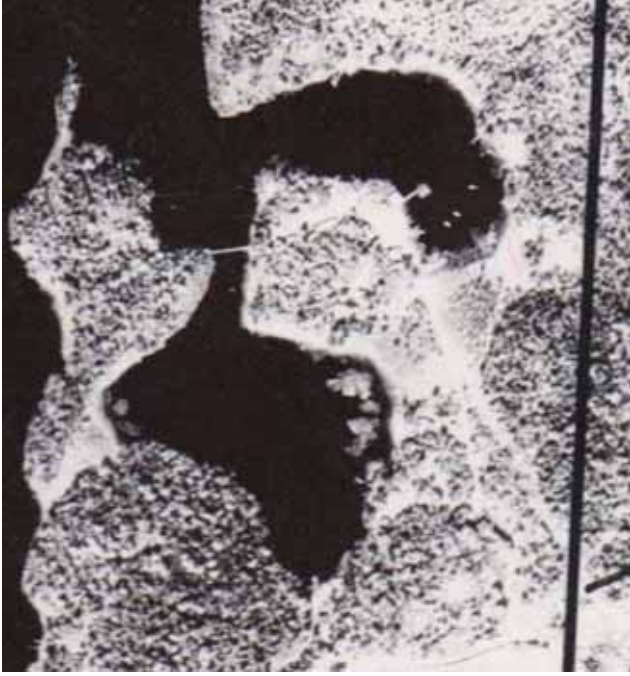
Figure 4- 3: Aerial photograph of Chik-Wauk property, 1961 (source: USFS Superior National Forest)

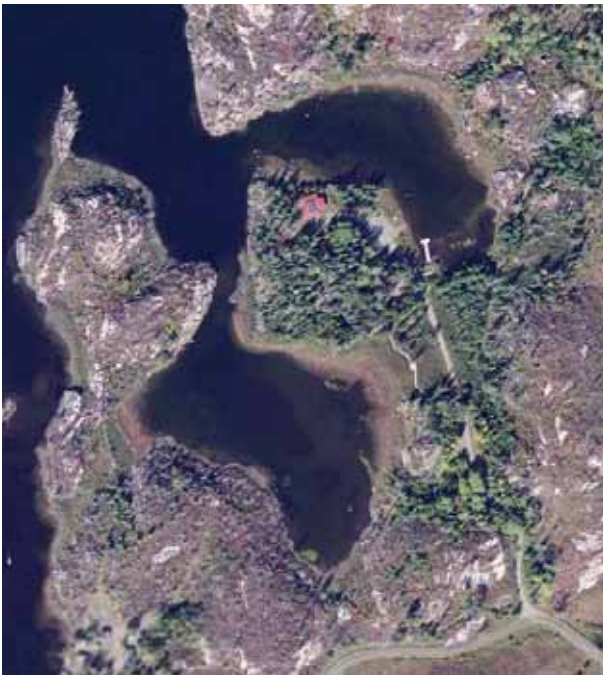
Figure 4- 4: Chik-Wauk property aerial view, 2011 (source: bing aerials)

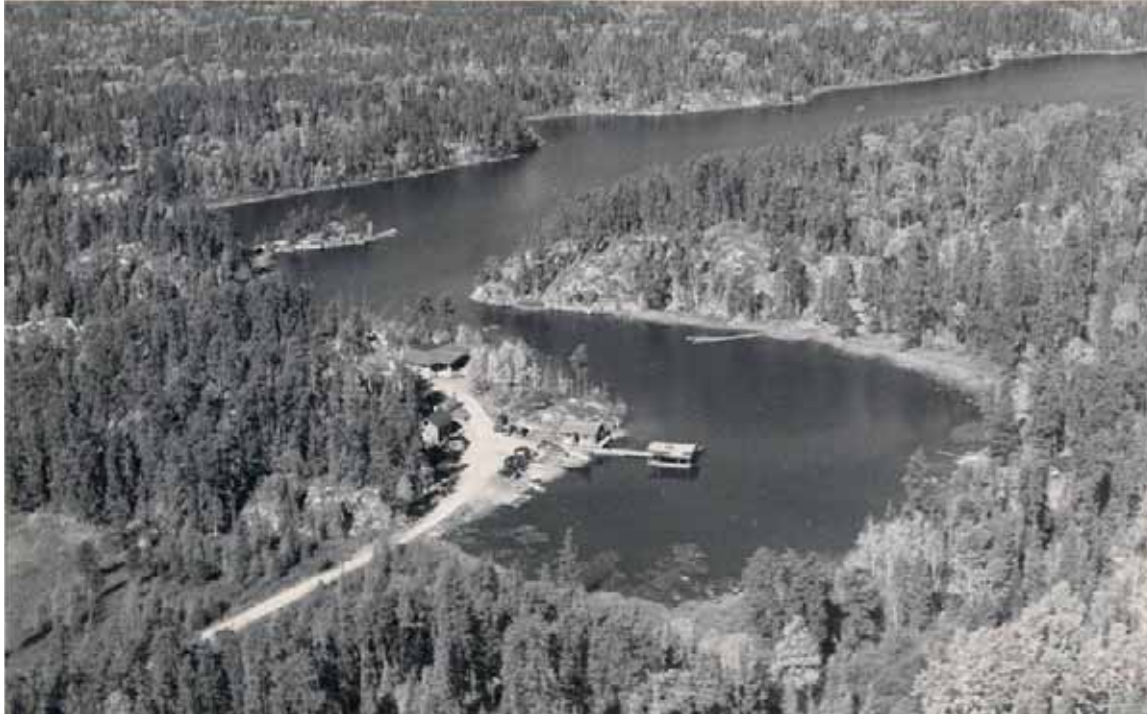
Figure 4- 5: Historic view of Chik-Wauk property, facing northwest. (source: C-W 61, image taken by Cliff Waters, donated by Barb Dull)

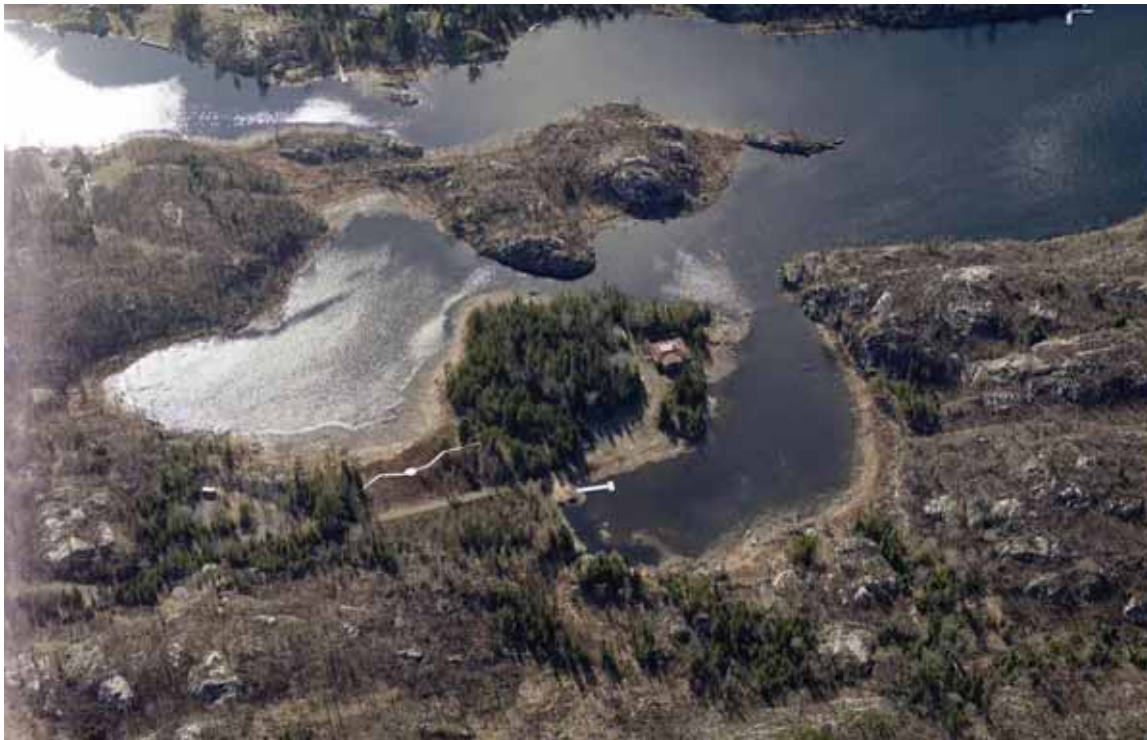
Figure 4- 6: Oblique view of Chik-Wauk property, facing northwest, 2012 (source: bing aerals)

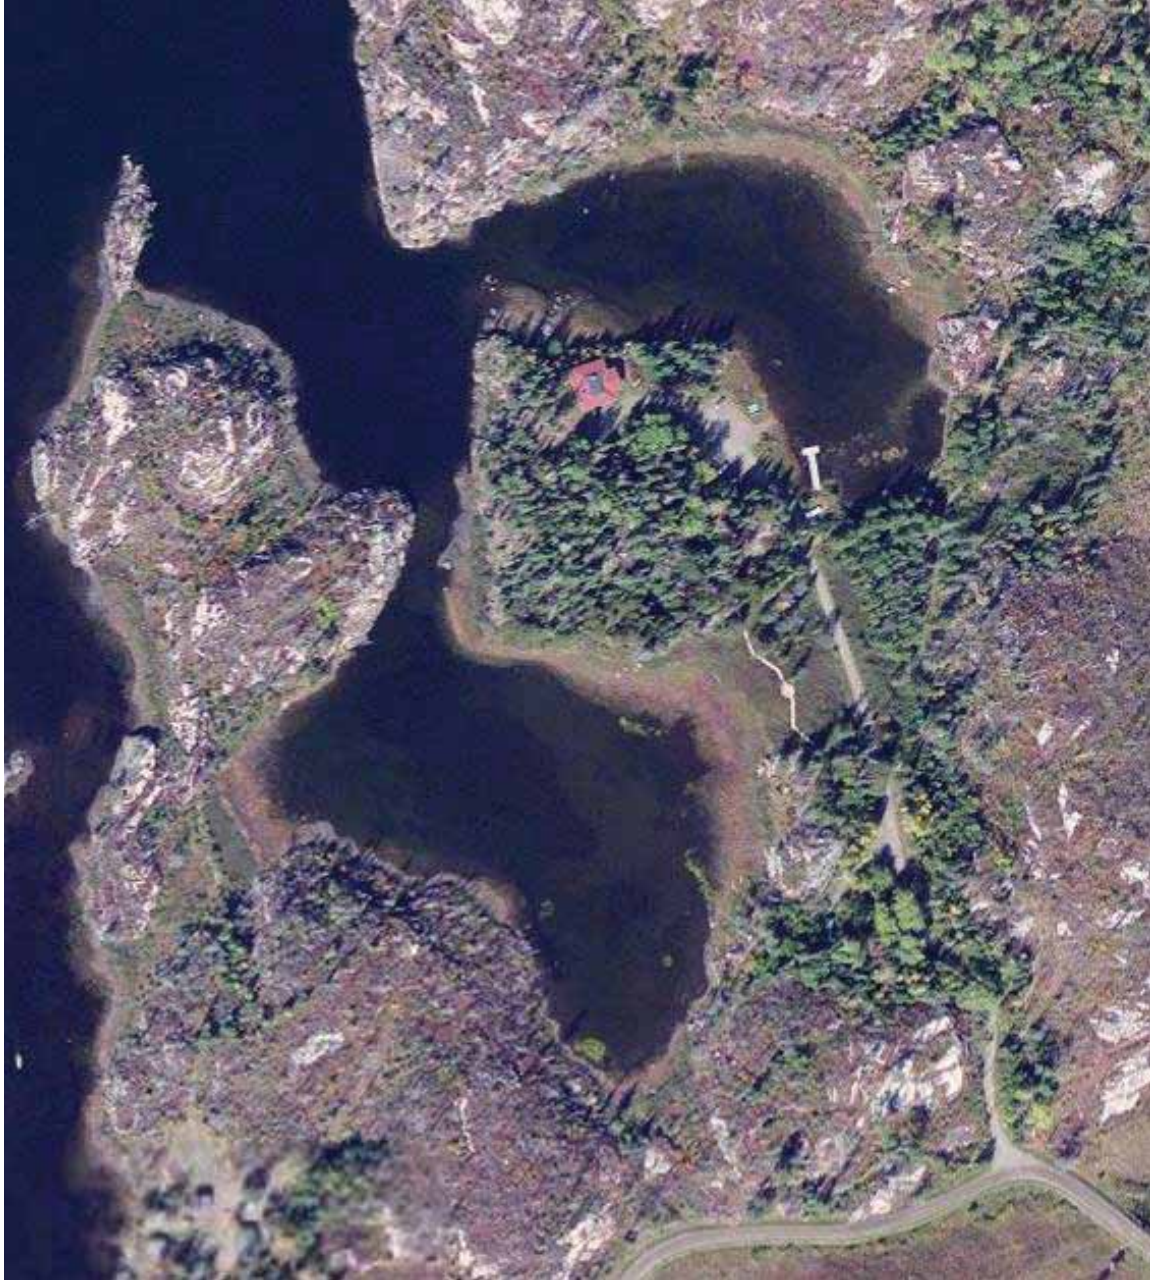
Figure 4- 7: Aerial photograph of Chik-Wauk property, 2012 (source: bing aerials)

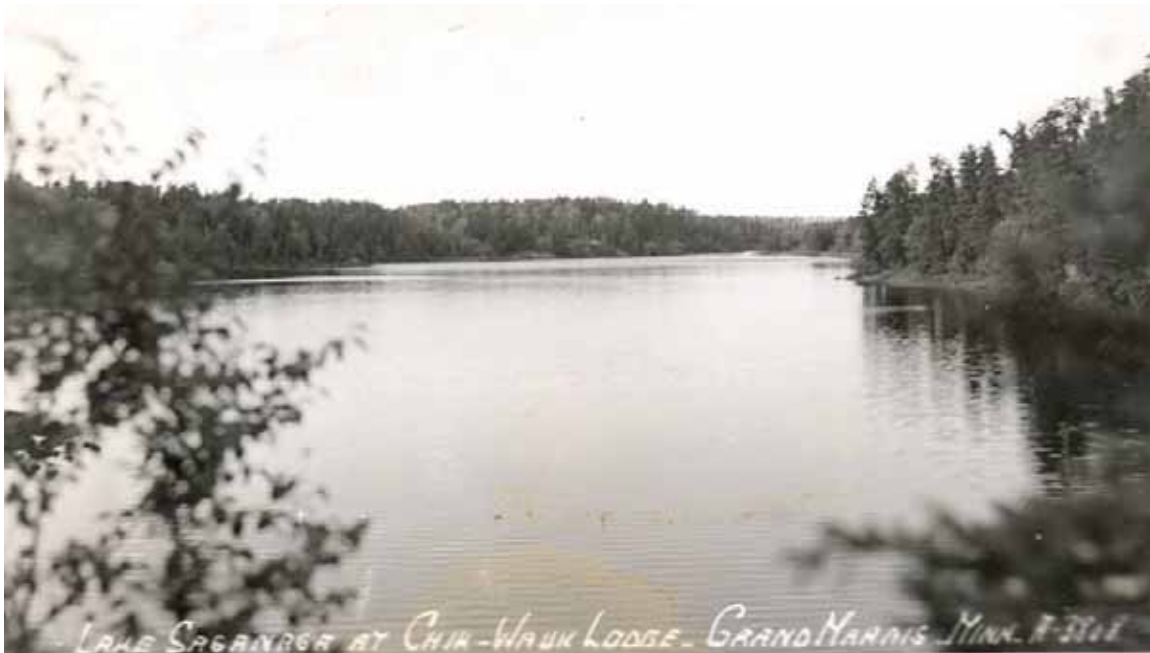
Figure 4- 8: HV #1: Historic View north from top of rock directly behind the lodge (source: Kerfoot C-W 20)

A rock outcrop directly behind the lodge (west) is a high point where a wind turbine was located during the Nunstedt period of operation (1931-1952). From the high point facing north a view of the south end of Saganaga Lake is provided. Comparison of HV#1 and EV#1 reveals that the overall composition of this view has remained intact. The land forms and lake are still the dominant features. Two vacation homes are barely visible on the far shore in EV#1. Their visibility is due to the loss of surrounding vegetation as a result of the Ham Lake Wildfire. As vegetation regenerates, these structures will be less visible.

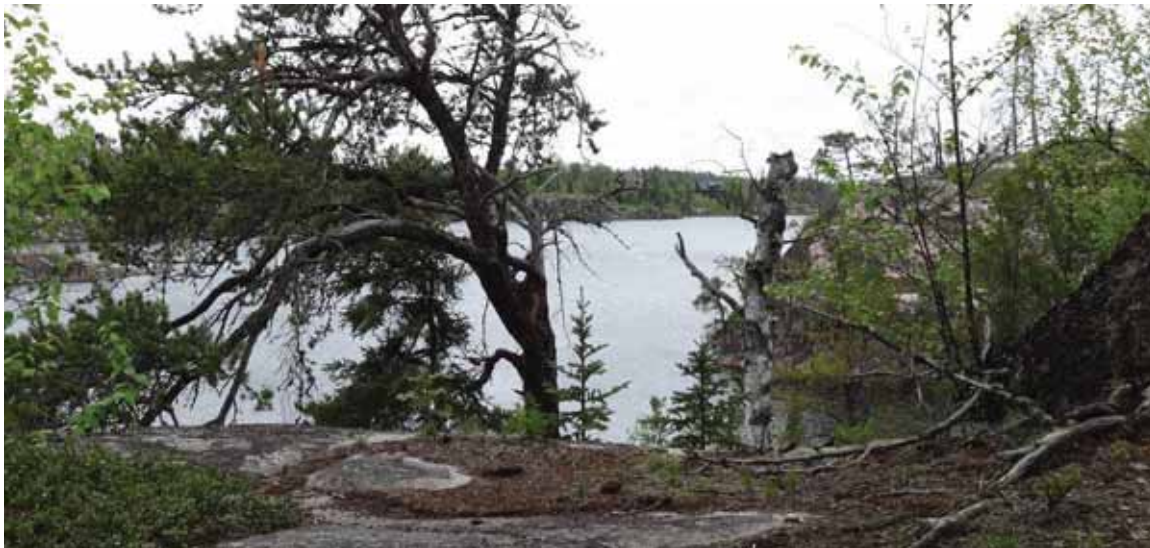
Figure 4- 9: EV #1: Existing View north from top of rock directly behind the lodge, June 2013, compare to HV #1 (source: QEA)

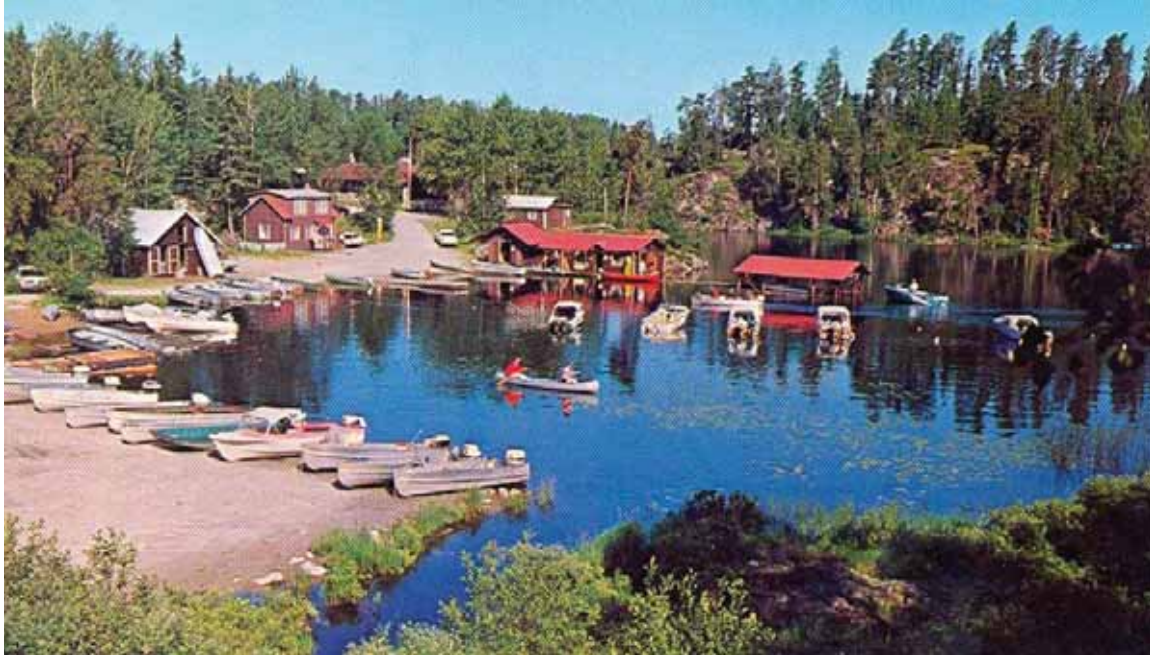
Figure 4- 10: HV#2: Historic View of Chik-Wauk Lodge and Canoe Outfitters, 1964. (source: Kerfoot, C-W 9)

A postcard featuring the boats, docks, and buildings in North Bay was used during the Griffis' tenure (1958-1980) for promotional purposes. Comparison of HV#2 to EV#2 reveals that the land forms have remained intact, but the numerous structures and activities associated with the historic resort are no longer apparent. The view today presents a very naturalistic scene where one might imagine extensive development had never occurred.

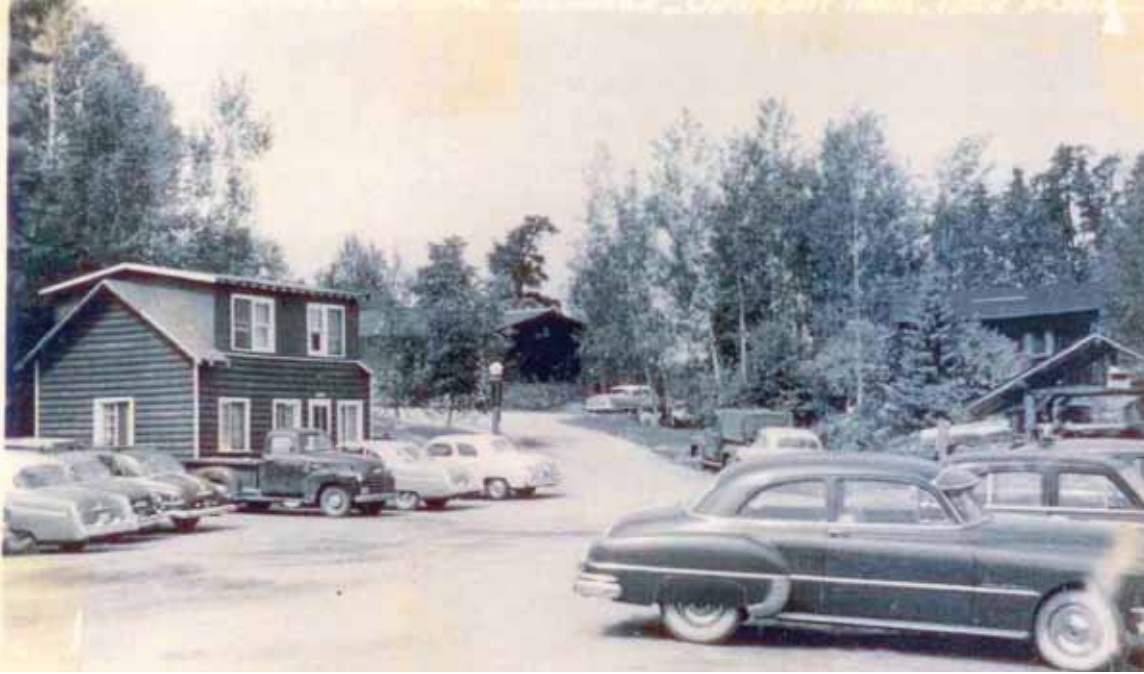
Figure 4- 12: HV#3: Historic View of main parking area at Chik-Wauk, ca. 1940s (source: C-W 165, Picture is from Gloria Martineau, daughter of Fred and Lola Drouillard.)

The parking/dock area at the resort was the major hub of activity during the historic period. Comparison of historic conditions in this area (seen in HV#3) to existing (EV#3) reveals that the presence of multiple buildings helped to define an arrival court during the historic era that is no longer apparent today. The continued use of the area for parking is definitely consistent with historic use, and the visual relationship between the parking area and the lodge and north bay area also intact.

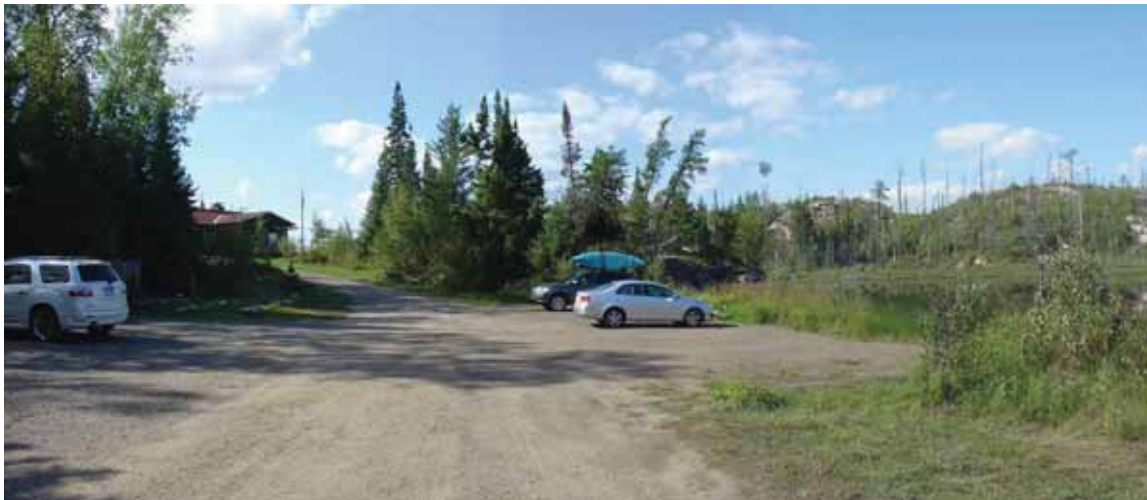
Figure 4- 13: EV#3: Existing View of main parking lot at Chik-Wauk, August 2012 (QEA)

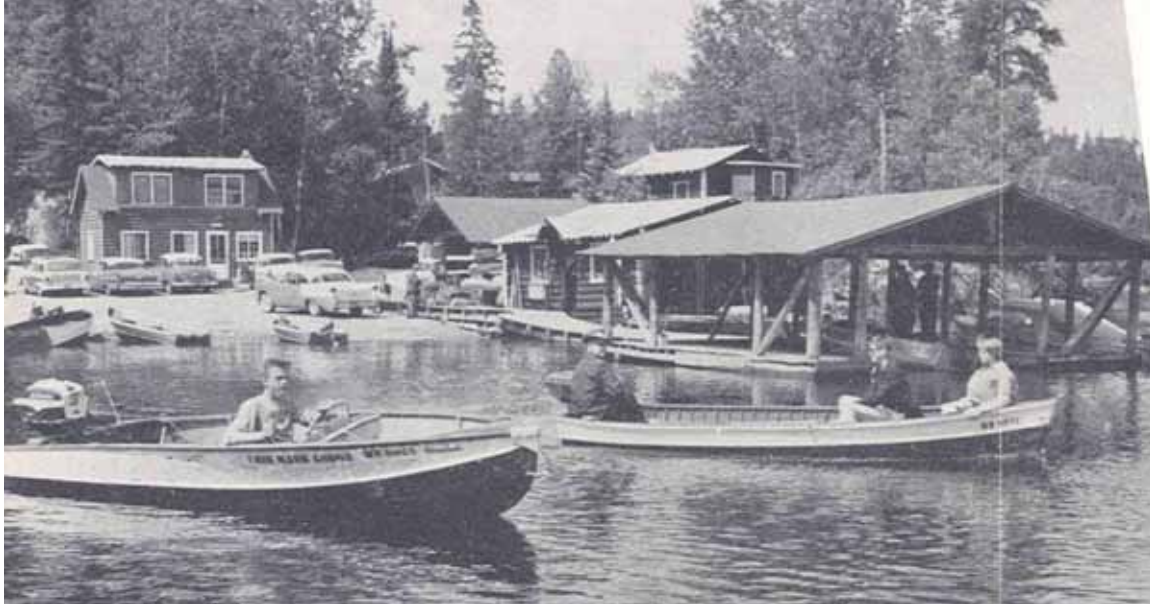
Figure 4- 14: HV#4, Historic View of office, boathouse and area around docks from the water ca.1960. (source: C-W 240a, excerpt from Chik-Wauk brochure, page 2)

Historically, spending time at Chik-Wauk Resort included getting out on the water in boats. HV#4 illustrates a typical historical scene at the resort, viewed from a boat in North Bay, where boaters departed and returned from fishing trips and other excursions. From the water, the lodge was in the background and multiple other buildings, including the office, boathouse, canoe outfitters building, and #4 Cabin were visible. Docks, boat landings, and automobiles were also important elements in the scene. A similar existing view presents a less active scene due to the loss of boats, buildings, and docks in this area.

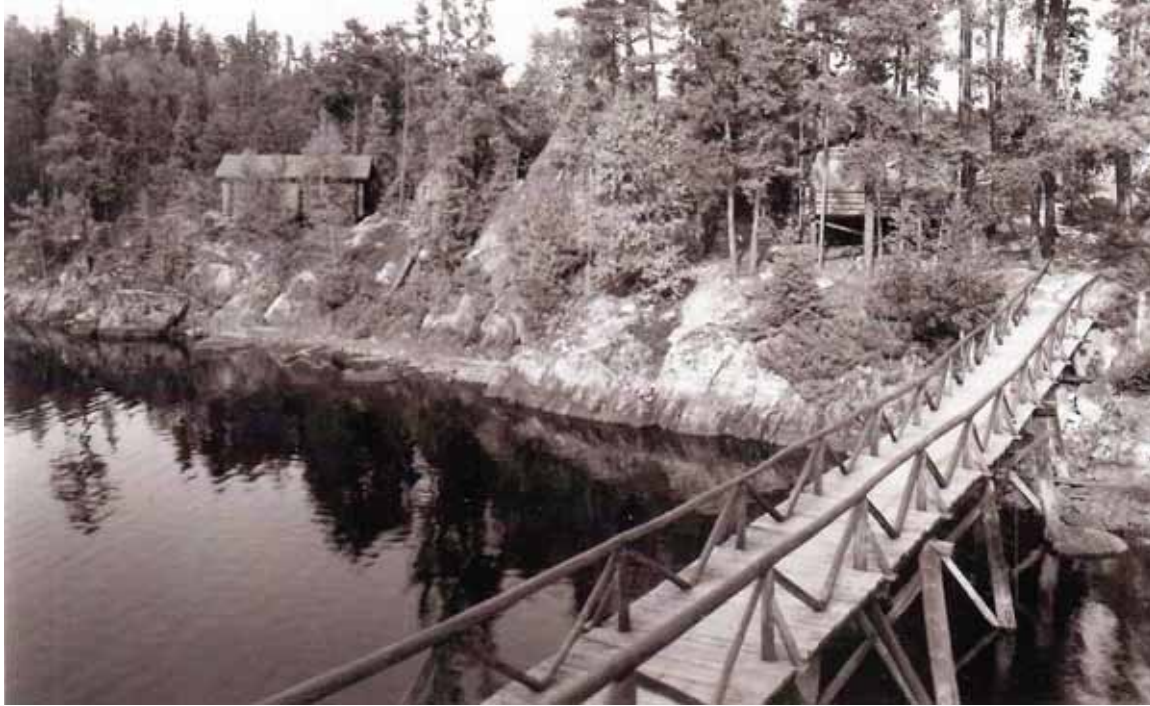
Figure 4- 16: HV#5, Historic View of Carey Cabin (#1 Cabin) at left, Judge's Cabin (#2 Cabin) at right, and pedestrian bridge, facing east, ca. 1940s (source: Nancy Nunstedt Borgen)

Access to the "Cabin Across the Bridge" (#3 Cabin) was provided by a wood pedestrian bridge from the north development area. The view from this cabin to the east included the bridge, rocky shoreline, and cabins perched on the rock outcrops. Although the bridge and cabins are no longer extant, the rocky shore line has remained greatly intact and recognizable.
