CULTURAL LANDSCAPE REPORT

FINAL - APRIL 2014

GUNFLINT TRAIL
HISTORICAL SOCIETY

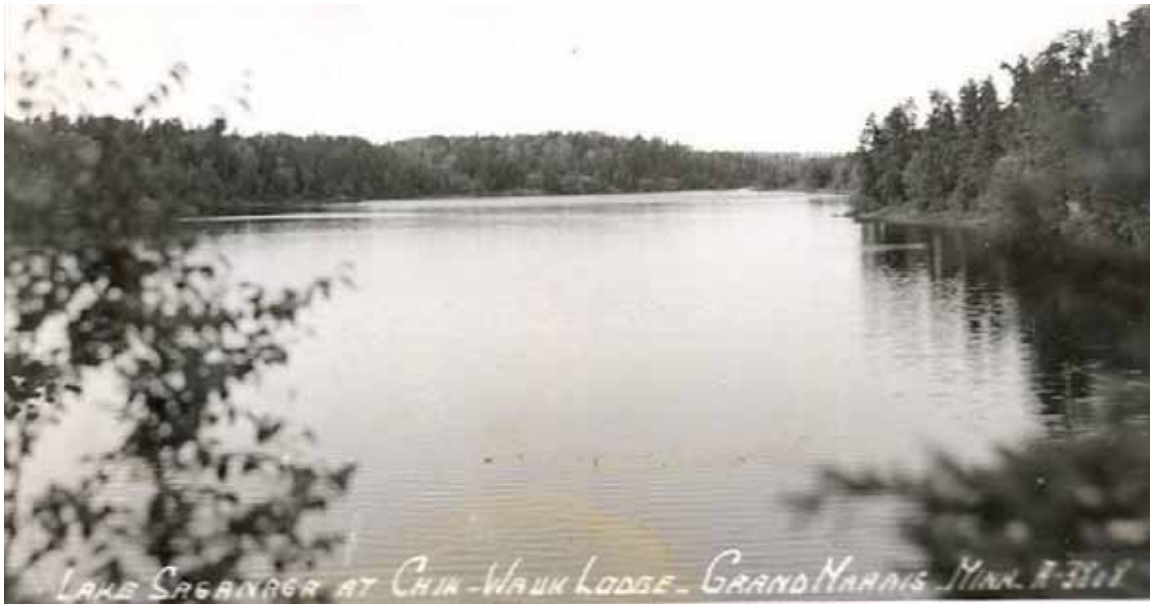
Figure 4- 18: HV#6, Historic View of Lake Saganaga from Chik-Wauk Resort (source: C-W 20)

Views of Saganaga Lake to the north from Chik-Wauk were expansive and beautiful, presenting a seemingly unexplored wilderness. This remains true today, as the view is greatly unchanged. The appearance of two vacation homes in the distance is a reminder of the fragility of this view. It remains intact because the landscape has remained the same and also because development of new elements have not imposed upon the view.

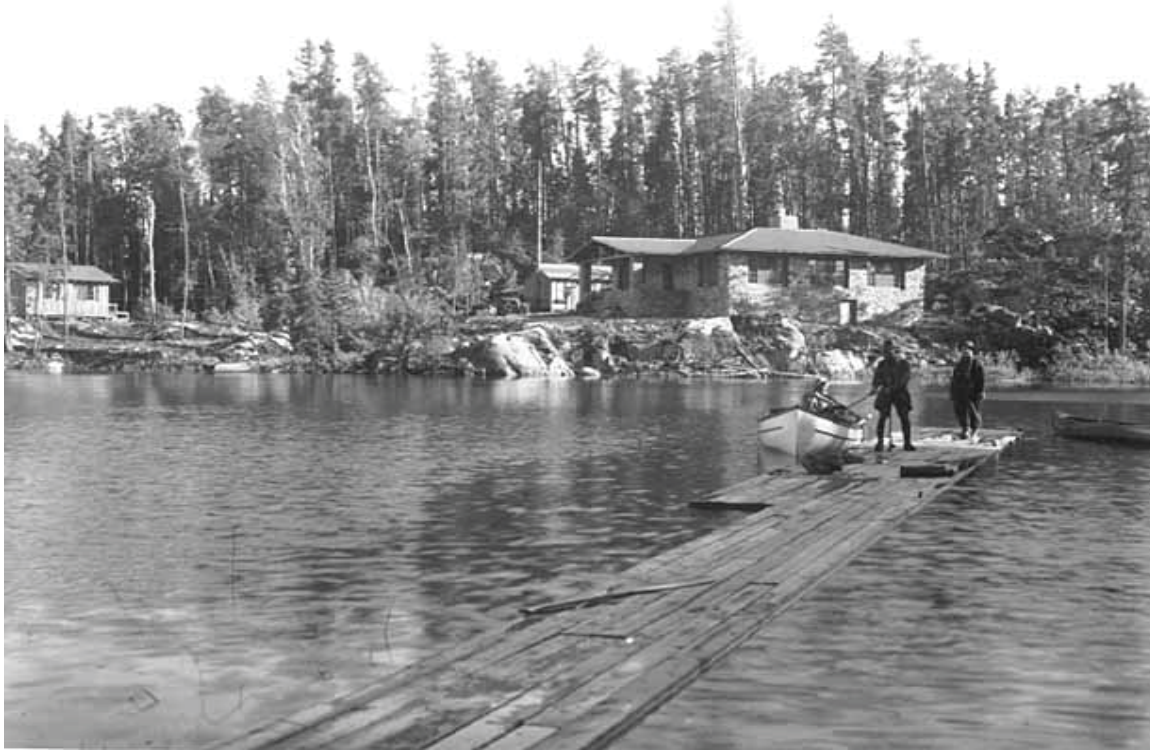
Figure 4- 20: HV#7, Historic View of Chik-Wauk lodge and surrounding area from across the bay, facing south, ca. 1936 (source: USFS)

Viewed from across the bay, the grading of the lodge site to create a level building location is apparent. Fill was added on the east side of the building. Today vegetation partially obscures views of the lodge from across the bay, but the scene is otherwise unchanged.

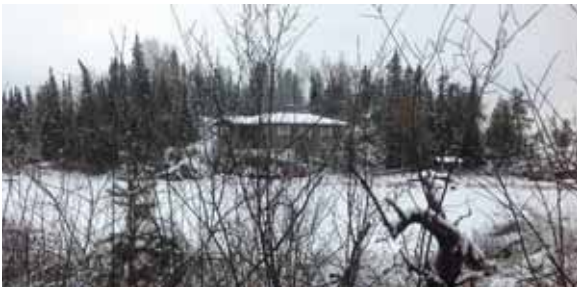
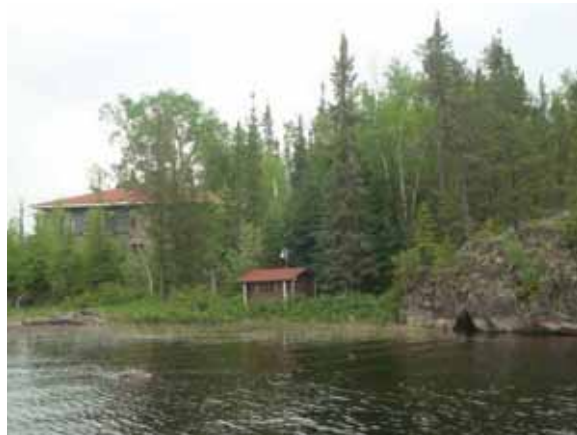
Figure 4- 23: EV#8, Left: Existing View of Chik-Wauk lodge and surrounding area from across the bay, facing south, December 2012 (source: QEA); Right: Existing View of Chik-Wauk lodge and generator building from the water, July 2013 (source: Bruce Kerfoot)

The relationship between the lodge, generator building, and Carey Cabin (#1 Cabin) is apparent in HV #8 and EV#8. Although the Carey Cabin is no longer extant, the rocky outcrop upon which it was situated remains. The wind turbine on the high point behind the lodge, and the laundry building to the south of the lodge are apparent in HV#8 as well. Comparison of these two images show the relationship between the lodge and surrounding landscape has changed very little.

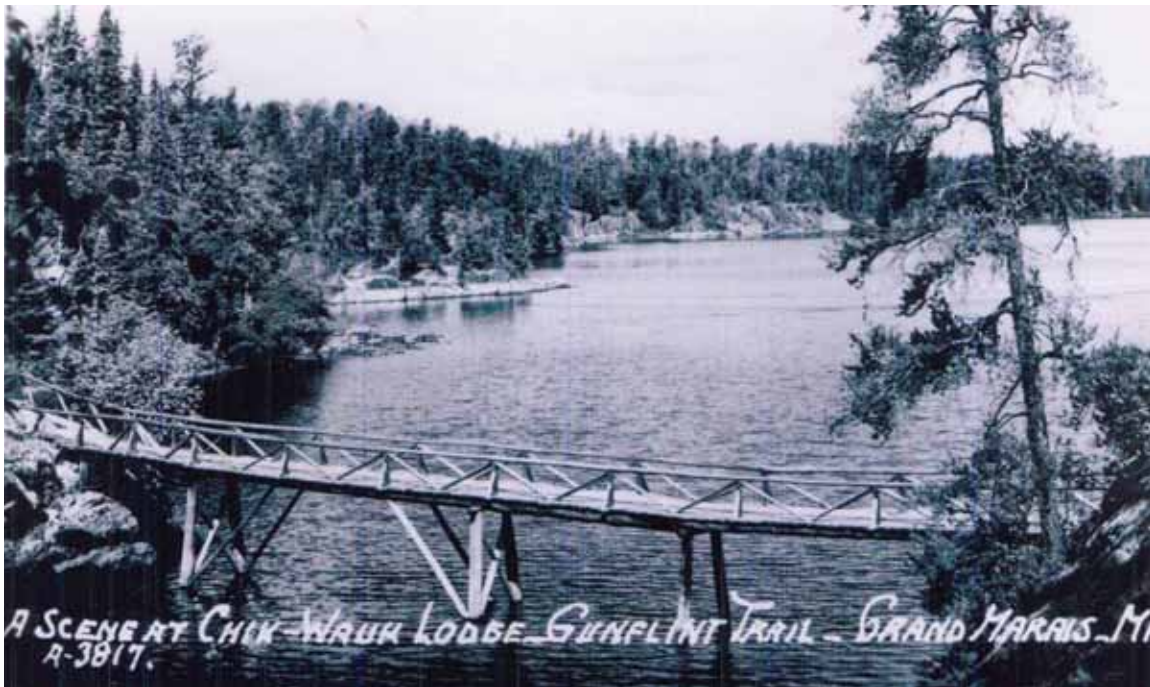
Figure 4- 24: HV#9, Historic View of pedestrian bridge and Saganaga Lake, from site of Crow's Nest Cabin (#6 Cabin), facing northwest (source: C-W 71)

Views from all of the American Plan Cabins were excellent during the period of resort operation (1931-1980). HV#9 illustrates the historic view from the Crow's Nest Cabin (#6 Cabin). The pedestrian bridge in the foreground provides an interesting built element in the otherwise naturalistic scene. Today the bridge is absent, but the shores of Saganaga Lake have remained consistent and the view is greatly intact. The lack of visible new development in this view is an important aspect as well.

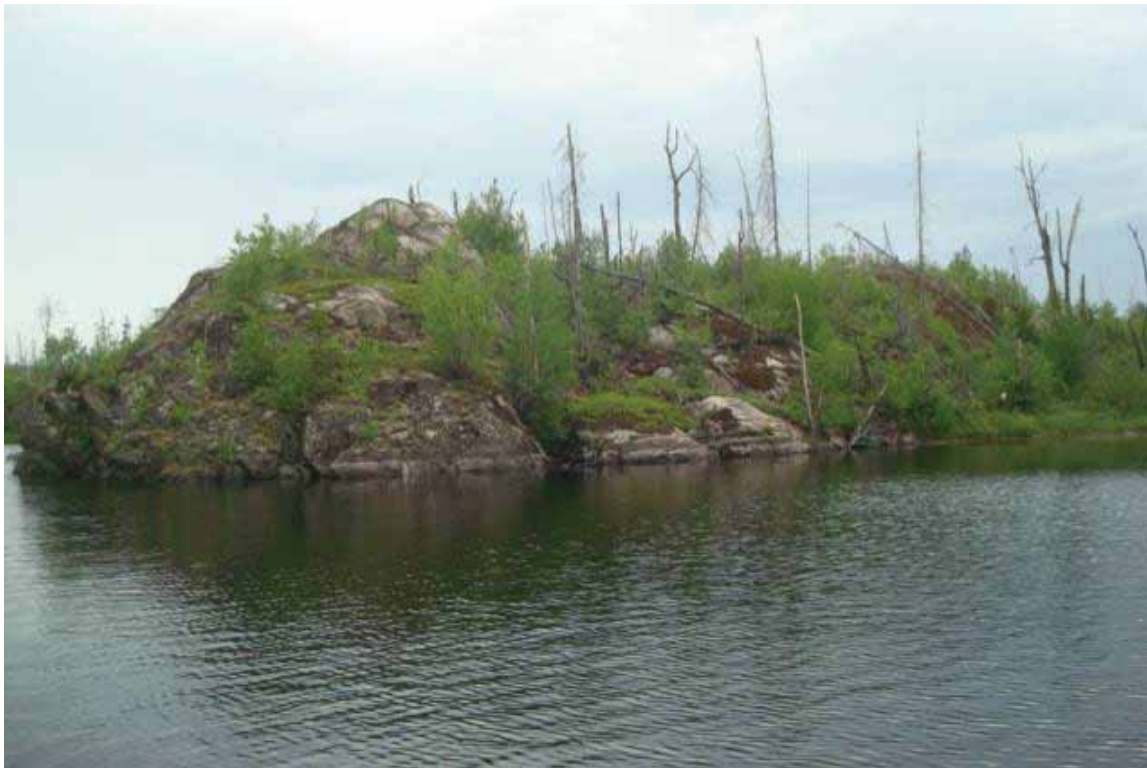
Figure 4- 26: Rock outcrops at the edge of Saganaga Lake, facing west toward the former site of the Cabin Across the Bridge (#3 Cabin), July 2013. (source: Bruce Kerfoot)

The interesting topographic features were utilized when developing the resort. The lodge and American Plan cabins were situated upon rock outcrops that afforded dramatic views of the surrounding landscape. The scenic qualities of the site were the result of the irregular shoreline, combined with diverse topography, dramatic rock outcrops and masses of evergreens and northern hardwoods. These combined provided a high level of visual diversity and interest. One example is at the entrance of the property, where a rock knoll rises above the road and provides a backdrop for the entrance sign (see Figures 4-27 and 4-28). The property retains a high level of integrity associated with topography.

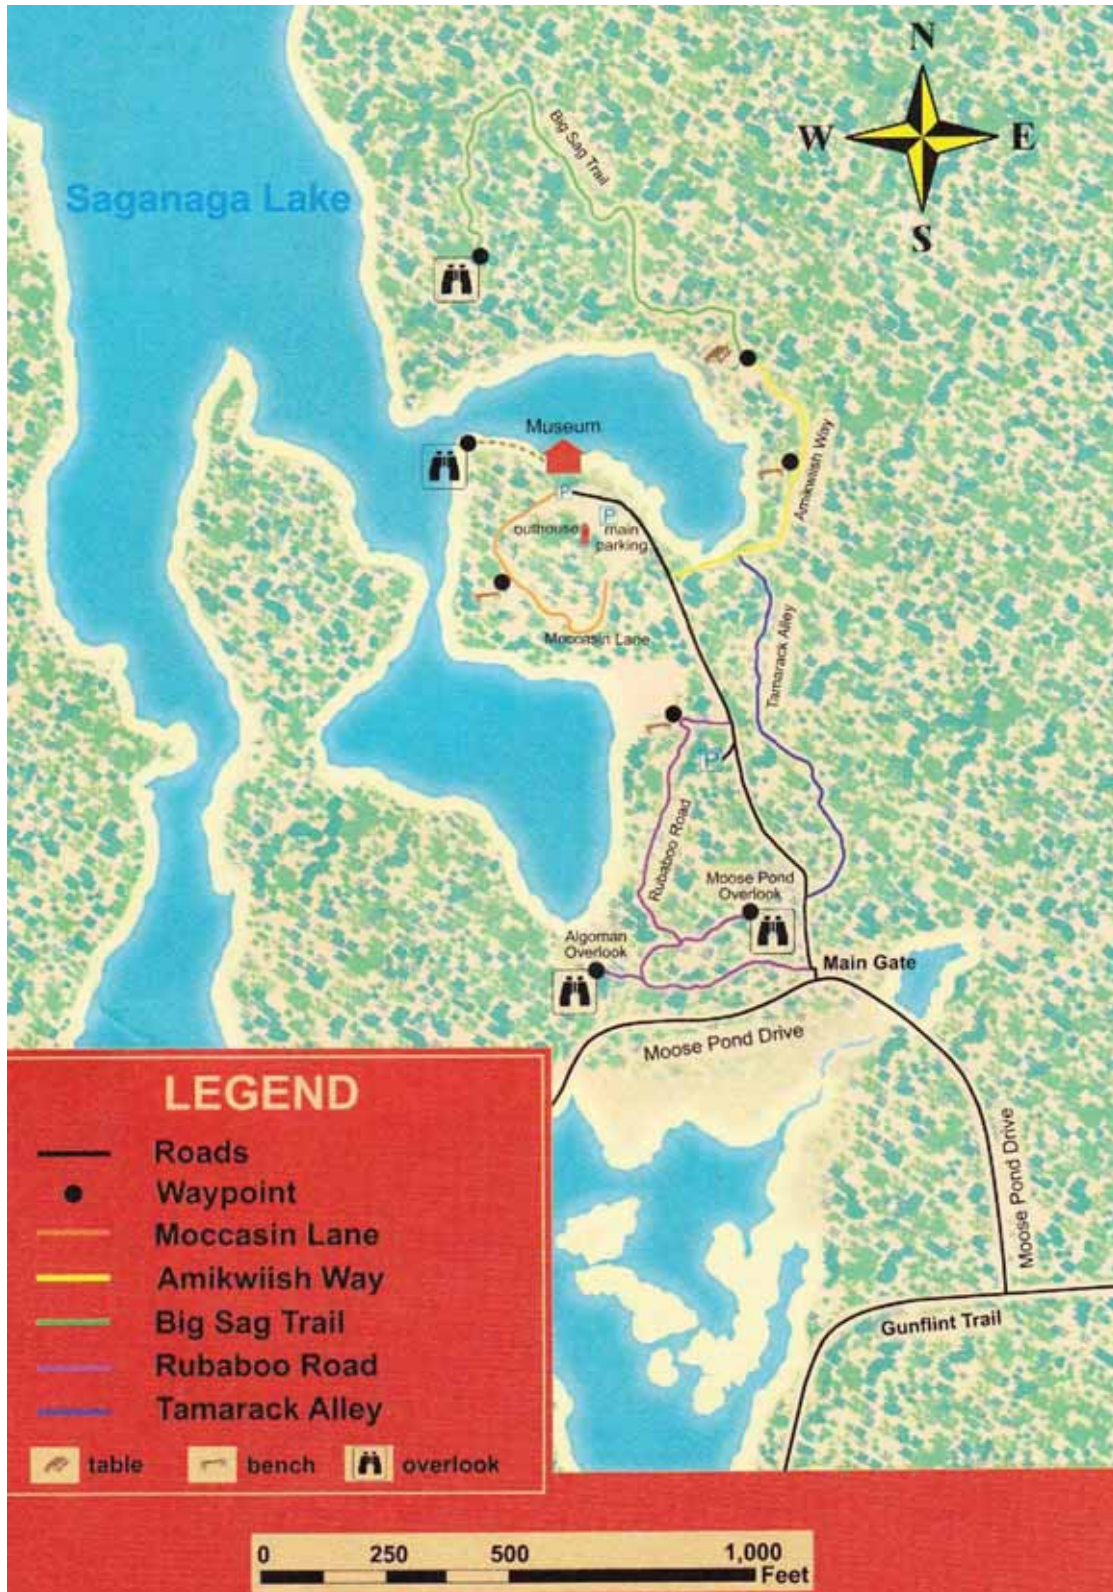
Figure 4- 29: Chik-Wauk Museum and Nature Center Trail Map, 2012 (source: Chik-Wauk Museum and Nature Center)

During the period of resort operation, trails at the resort were limited to those providing access to the buildings, the pedestrian bridge, and a trail that extended to the northeast to a site called "Lookout Point." Current trails on the property that related to those historic routes include Moccasin Lane, Rubaboo Road, and Amikwiish Way.

Patterns of circulation contribute to the significance of the Chick-Wauk landscape. The entrance road, parking area, and three trails (Moccasin Lane, Rubaboo Road, and Amikwiish Way) retain integrity.

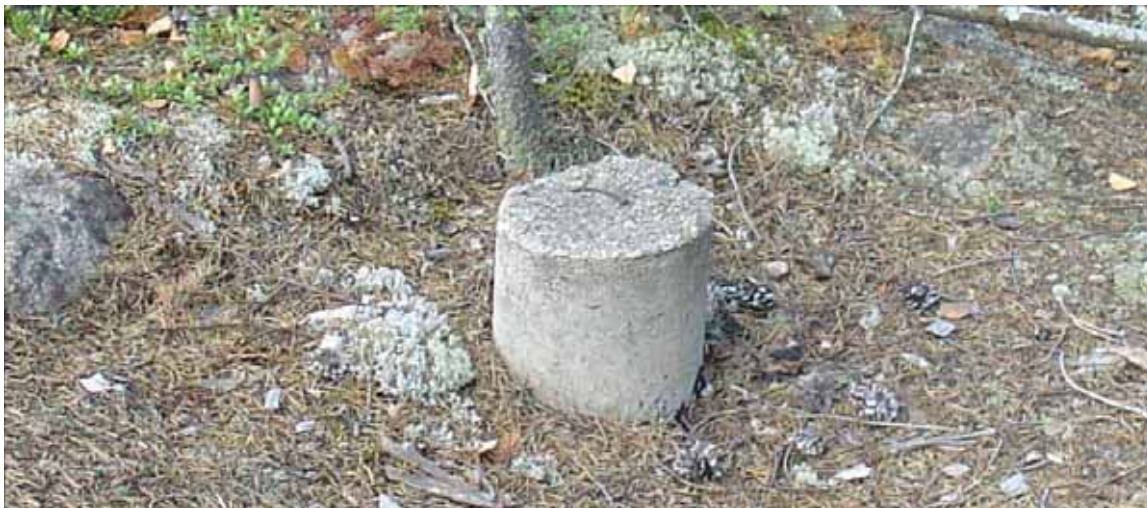
Figure 4- 34: Circular concrete cabin foundation post at cabin site, August 2012 (source: QEA)

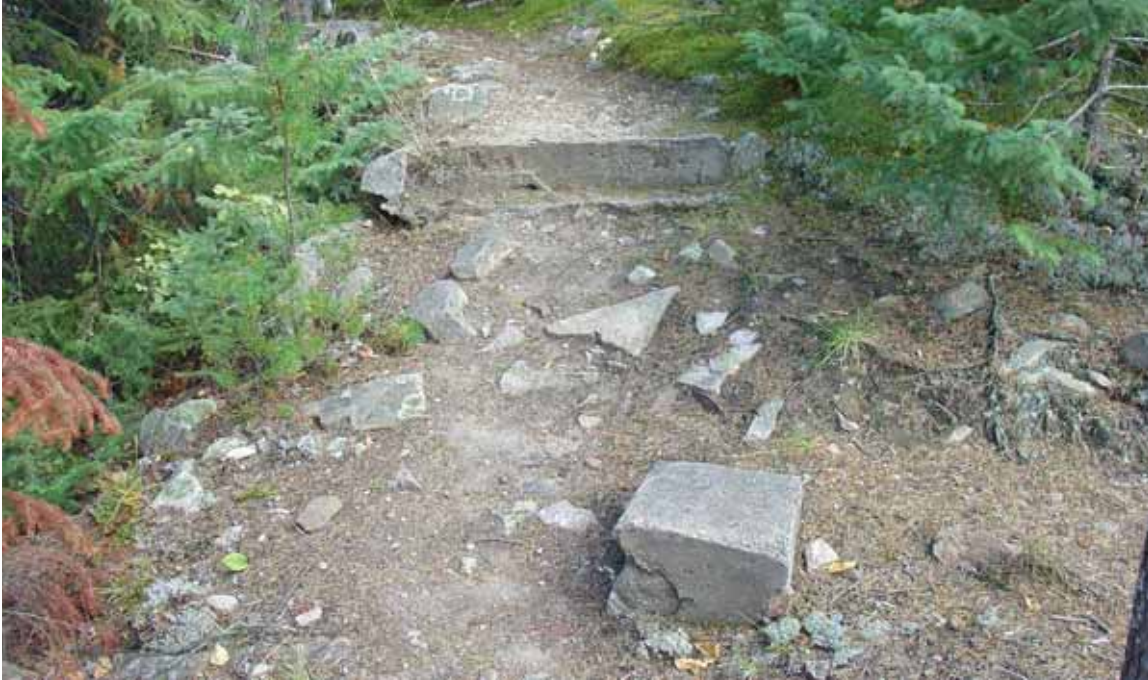
Figure 4- 35: Threshold (background) and square concrete cabin foundation post at Carey Cabin (#1 Cabin), August 2012 (source: QEA)

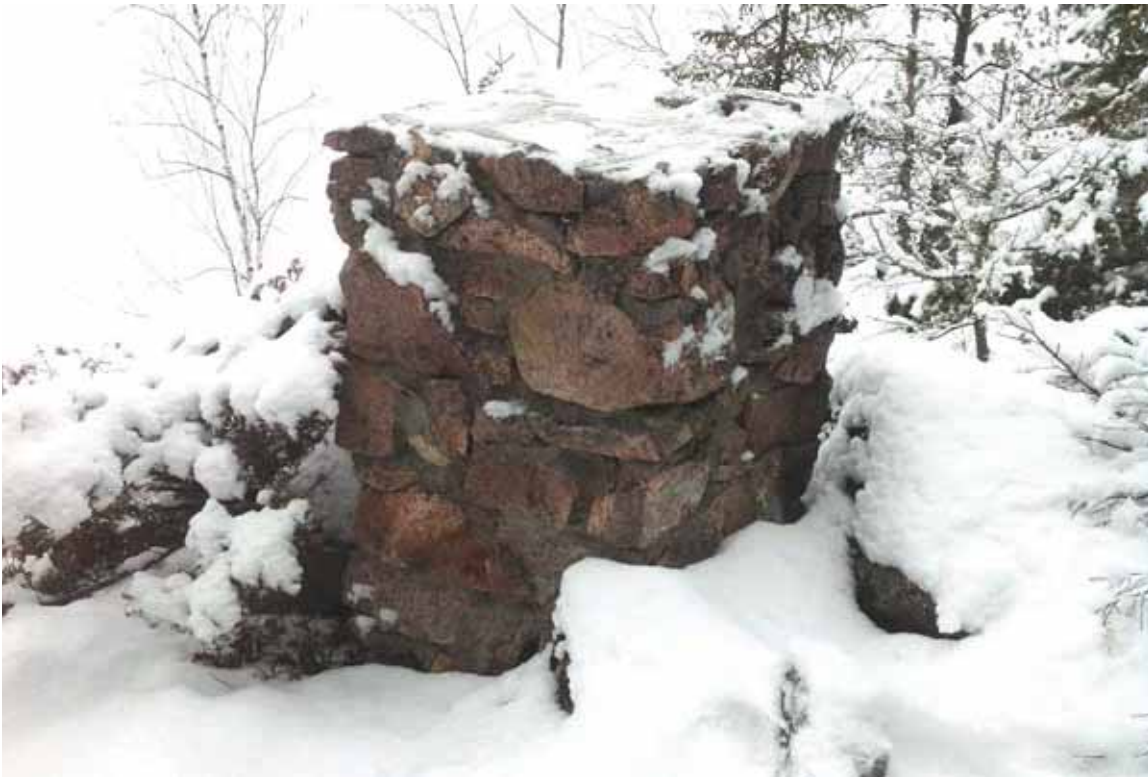
Figure 4- 36: Mortared stone foundation pillar at former Carey Cabin (#1 Cabin), December 2012 (QEA)

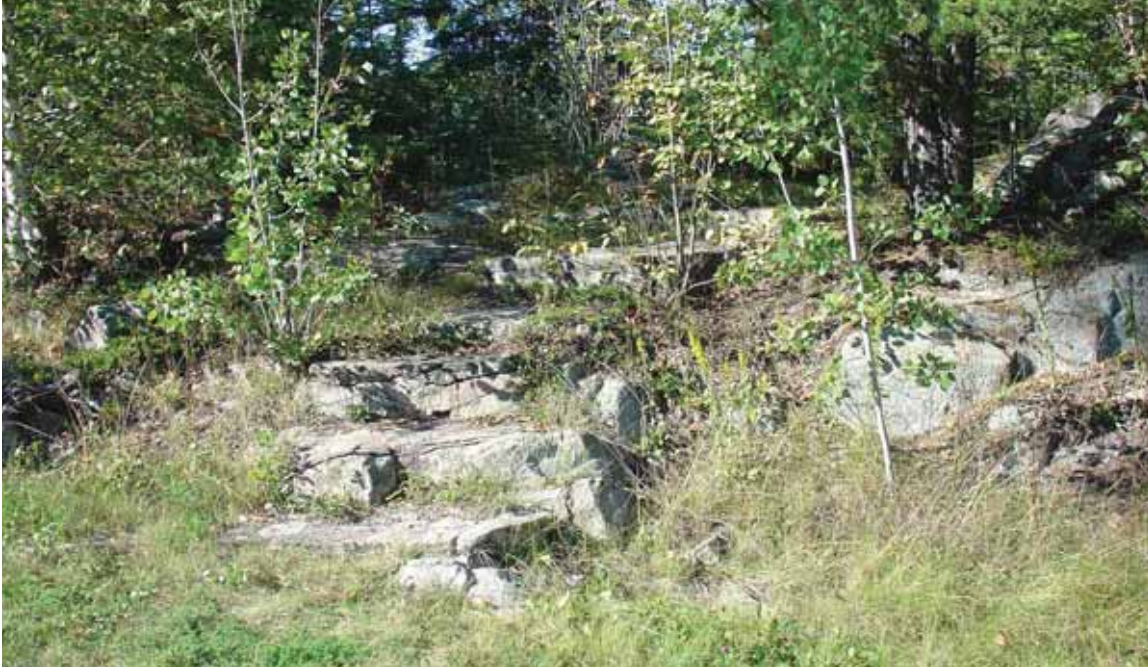
Figure 4- 37: Stone steps at former site of Guest Cabin #1 (#4 Cabin), August 2012 (QEA)

Small scale features are elements that provide detail and diversity combined with function and aesthetics at historic landscapes. At Chik-Wauk these fall into two categories, including those that are extant resources that date to the period of significance and new features that have been added since 1980. The extant resources contribute to the historic significance of the property and include concrete and mortared stone building foundation piers (present at former cabin sites), stone steps, stone path edging, the foundation of a former water tank, and a stone barbecue pit.

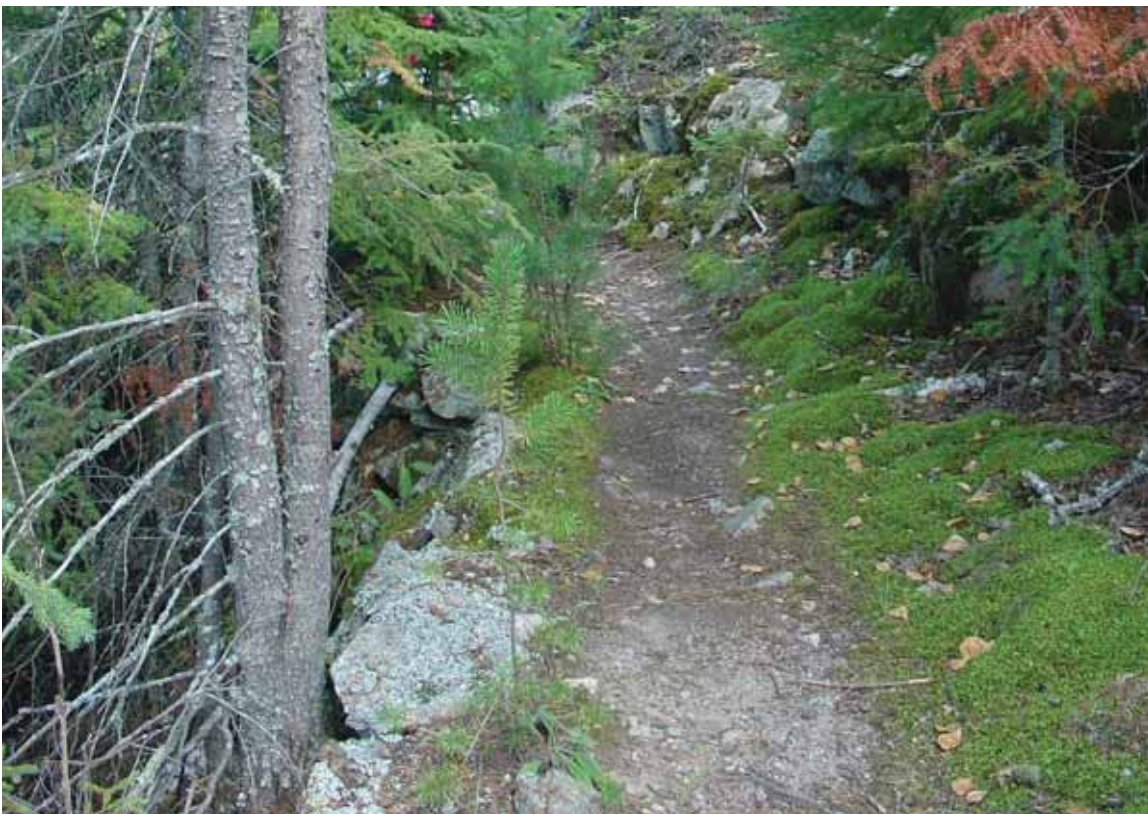
Figure 4- 38: Stone edged path south of Crow's Nest Cabin (#6 Cabin), August 2012 (source: QEA)

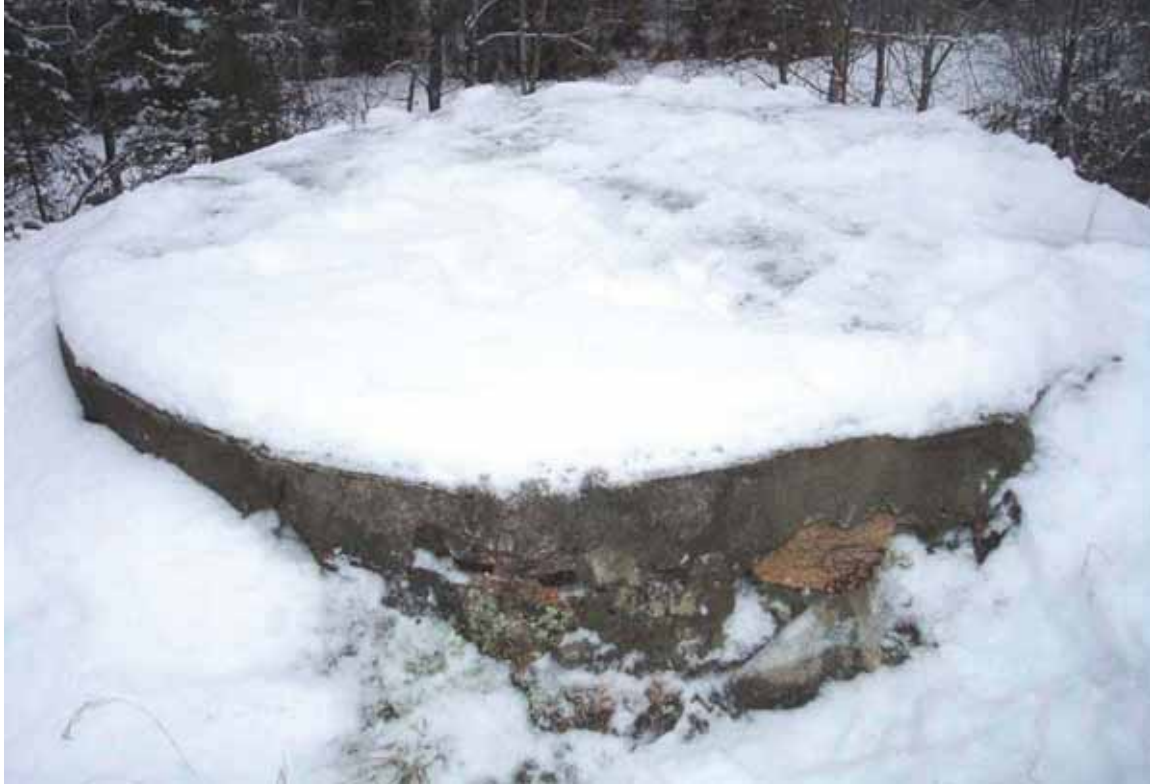
Figure 4- 39: Stone and cement circular foundation of former water tank, December 2012 (QEA)

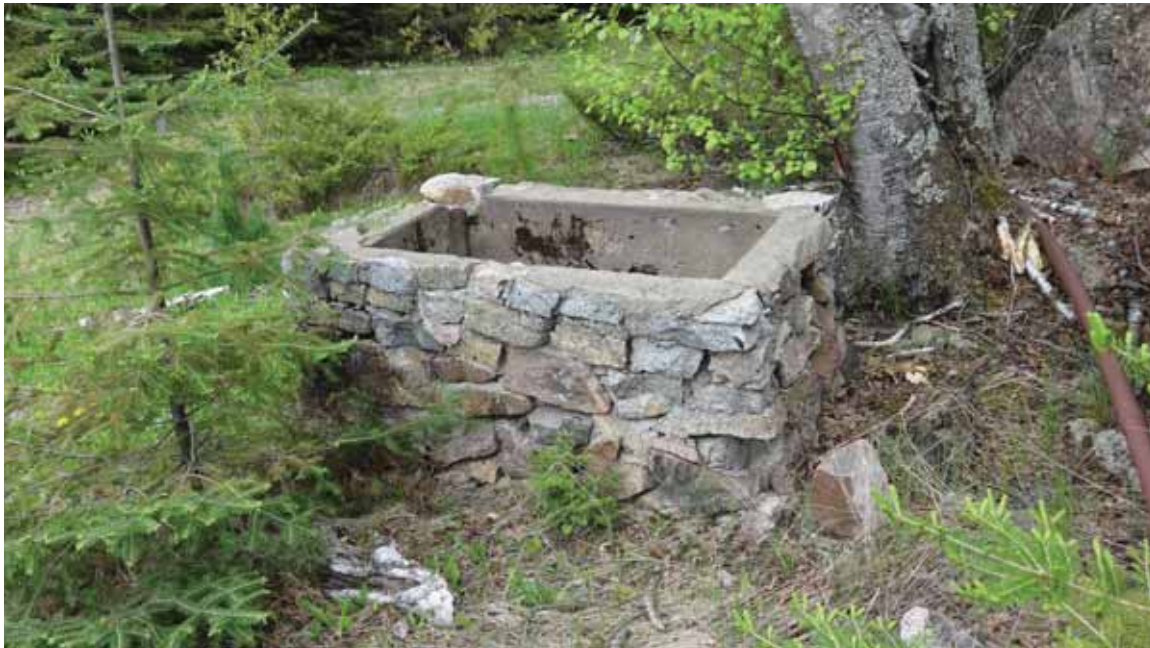
Figure 4- 40: Mortared stone barbecue pit, June 2013 (source: QEA)

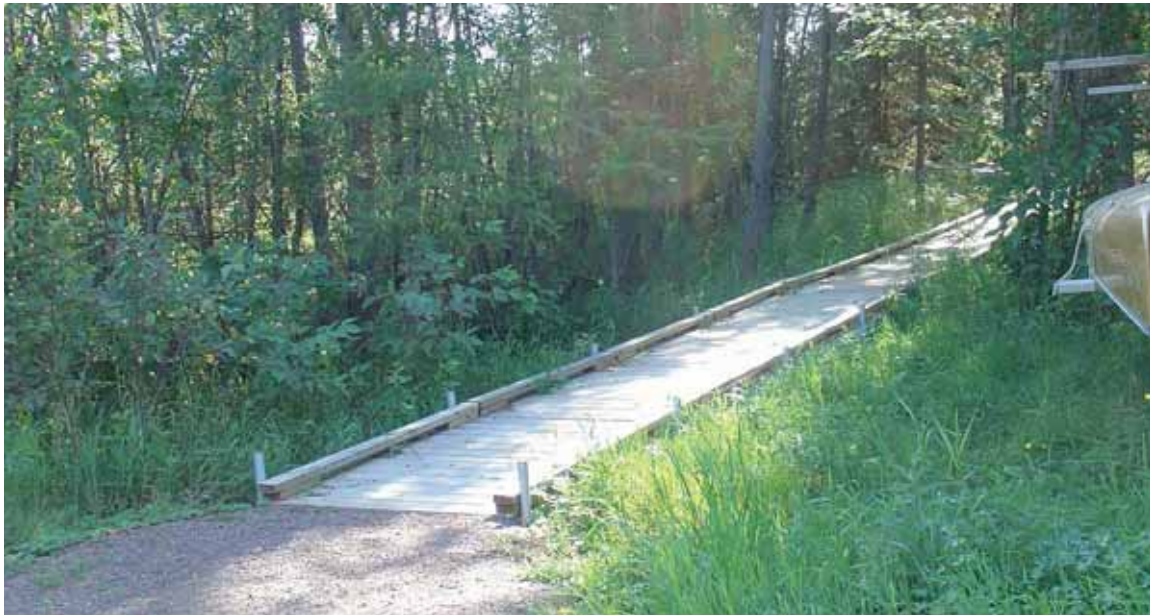
Figure 4- 41: Boardwalk near relocated canoe trip outfitting building, August 2012 (source: QEA)

Non-contributing small-scale features include a boardwalk, wood steps, interpretive signs, information signs, a stone edged path, a soda machine, screen fence, and small garden with an old stove at the edge of the parking lot. The majority of these features are compatible with the historic landscape and do not impact the integrity of the property. The soda machine, stone lined path and garden with a stove and hand pump in it are not compatible with the historic landscape, as they present a confusing scene that appears to relate to historic conditions, but does not.

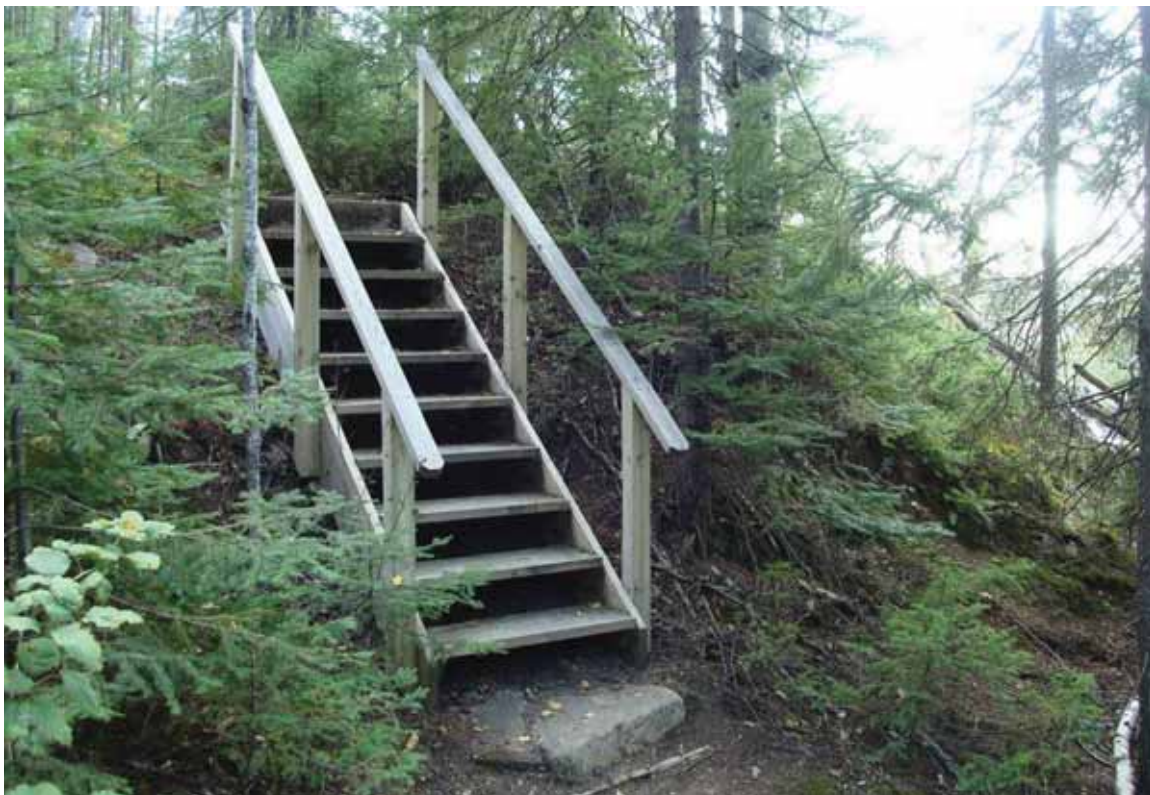
Figure 4- 42: Wood steps southwest of lodge, August 2012. (source: QEA)

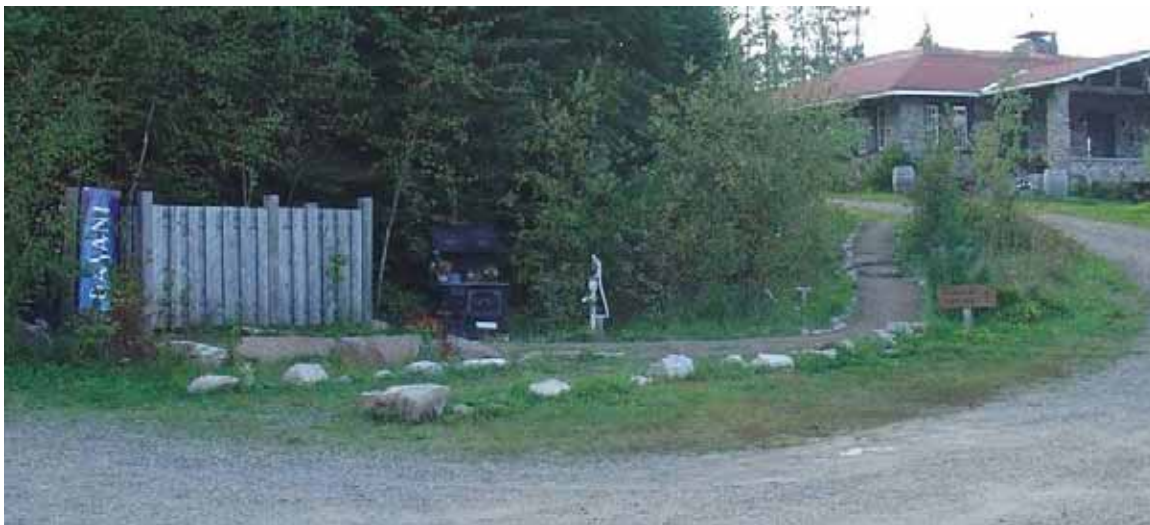
Figure 4- 44: Soda machine, screen fence, stove, pump, and stone lined path, August 2012 (source: QEA)
